Stern tube gland leak

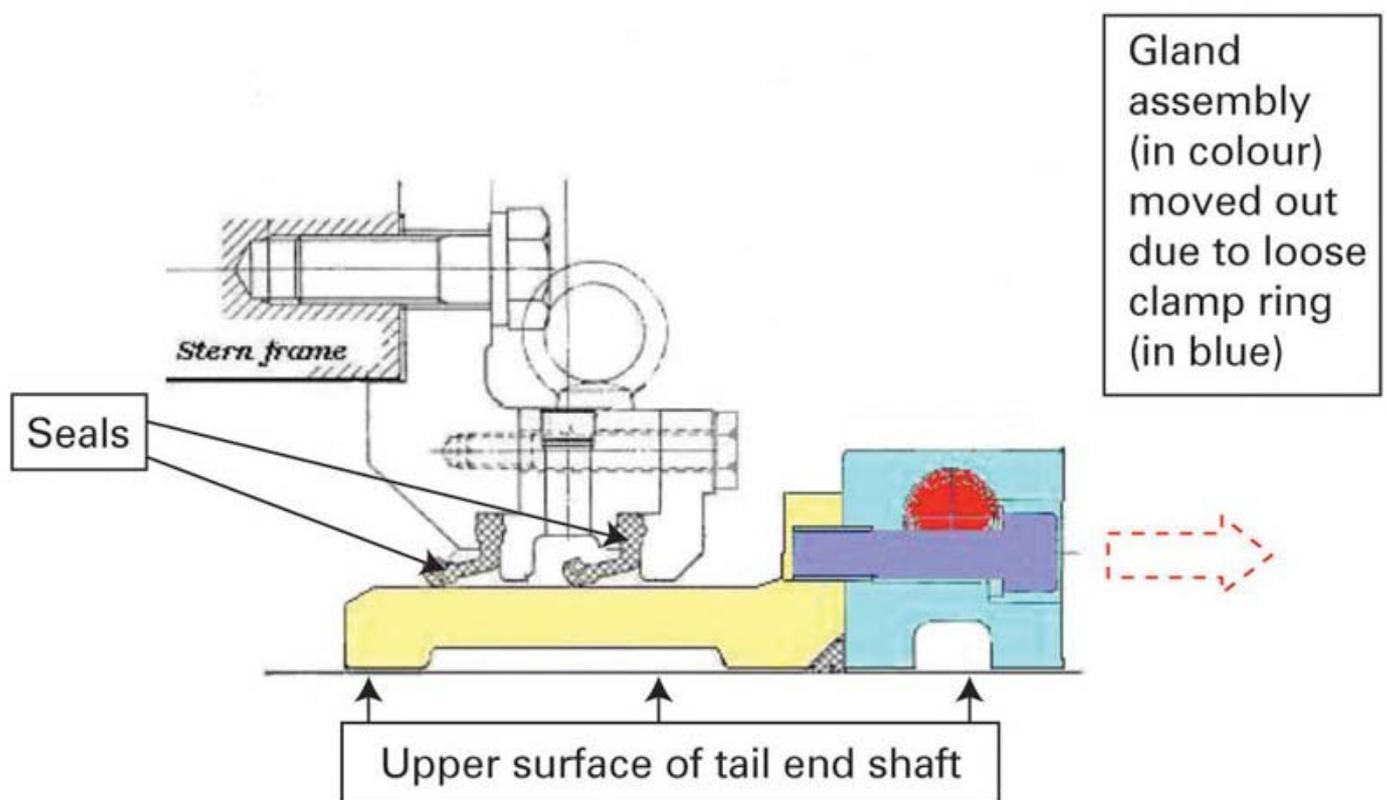
Before any damage was caused to the stern tube bearings and seals, the engine was quickly stopped and on investigation, it was noticed that the rotating seal gland (colored components in Figure) had moved out by more than 60 mm.

The rotating gland is held in place by a two-piece clamp ring (shaded in blue) that is tightly mounted on the tail shaft and is also connected to the bush (shaded in yellow) by means of bolts (shaded in purple), maintaining the forward seal gland in position. Fortunately, the ship's staff managed to re-position the bush and clamp ring correctly and the vessel resumed the passage without further problems.

Figure 2: Longitudinal section of upper half of inboard rotating stern tube gland, showing bush (yellow), clamp ring (blue), connecting bolt (purple) and clamp ring bolt (red)

It was concluded that after the last tail end shaft and docking survey two months ago, the shipyard staff had failed to fully tighten the bolts of the two-piece clamp ring (shaded in red) on the tail shaft, which resulted in the clamp ring along with the gland bush moving out of position over a period of time.

1. All engine room watchkeepers must be vigilant during watch;
2. After major surveys/maintenance, it must be ensured that all components are re-assembled and tightened to proper specifications.
