Auxiliary boiler explosion on board *Saldanha* off Newcastle, 18 November 2008

ABSTRACT

On 18 November 2008, while the Maltese registered bulk carrier *Saldanha* was anchored off Newcastle, NSW, a ship's engineer was burned when the auxiliary boiler furnace 'flashed back' during a routine boiler oil firing unit burner exchange.

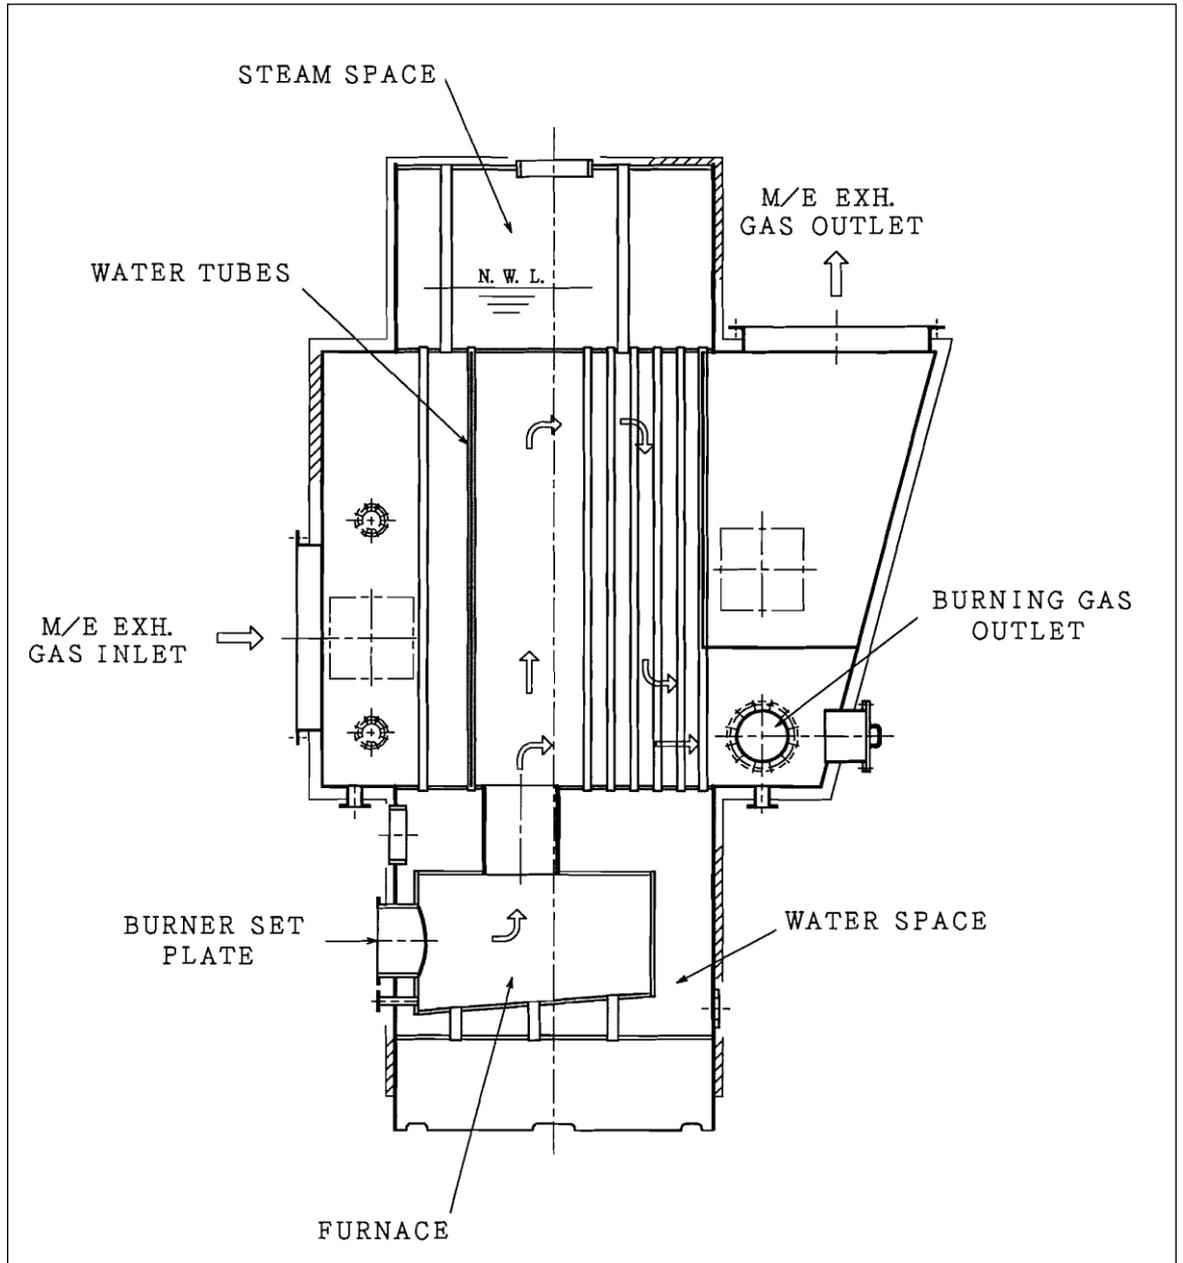
Figure 2: Diagram of Osaka OEVC3 boiler

Saldanha was fitted with an Osaka Boiler Mfg Company OEVC3-120/90-19 vertical composite boiler (Figure 2) with a working pressure of 6.9 bar³. The steam produced by the boiler is used on board the ship for the heating/treatment of heavy fuel oil and for general purpose heating.

When the oil firing unit was shut down, and the automatic purge cycle was completed, there would have been no flow of air through the furnace until the third engineer removed the burner maintenance cover. With the maintenance cover removed, the air flow through the furnace was dependent upon the ambient pressure in the engine room and the natural updraught within the boiler due to the hot exhaust gas uptakes. As a result, the air flow through the furnace was limited; probably passing directly from the oil firing unit opening to the smoke box inlet, leaving areas adjacent to the furnace floor and walls relatively unswept (Figure 2).

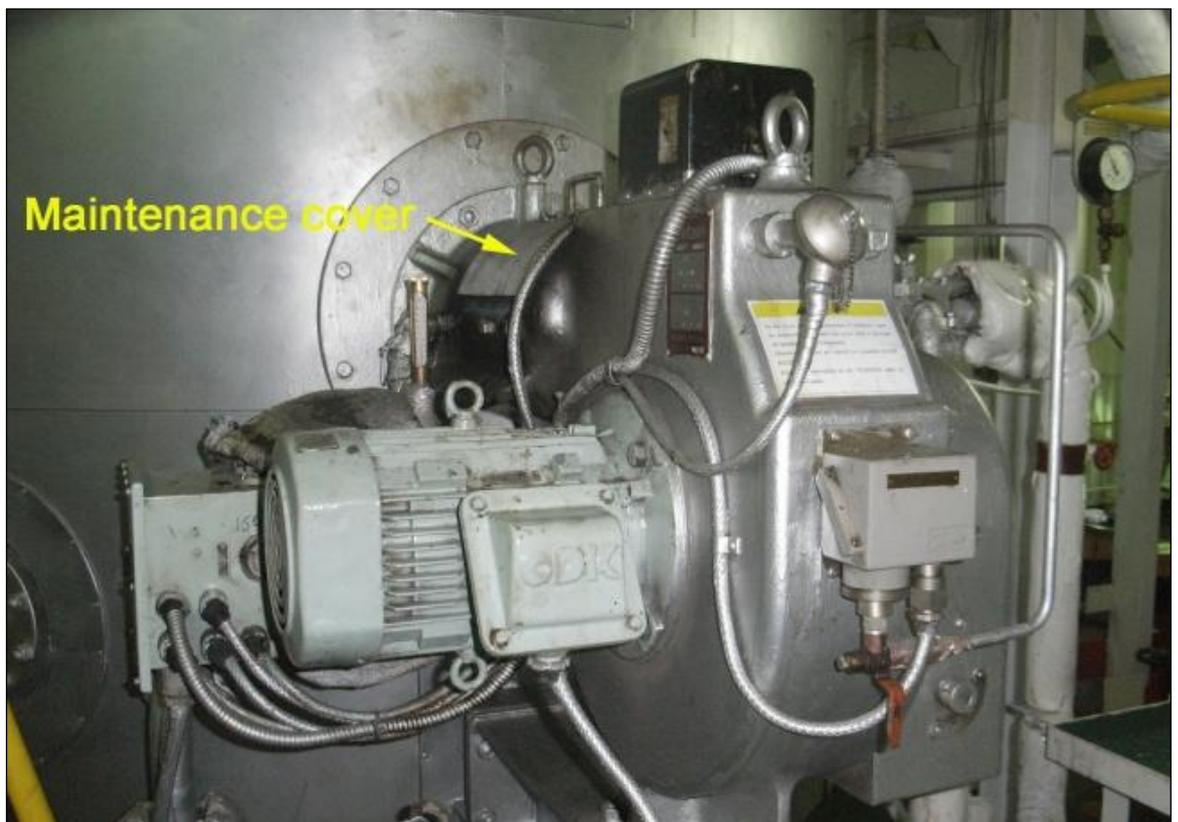
Figure 3: Boiler oil firing unit

The oil firing unit, model number VJ-140-3, was manufactured by the Volcano Company of Japan (Figure 3). It comprises a fully automatic pressure jet oil burner, integrated with a single electric

The burner may be removed from the oil firing unit through a maintenance cover at the top of the oil firing unit (Figure 3), after the ignition electrode cables and the three fuel pipes have been disconnected.

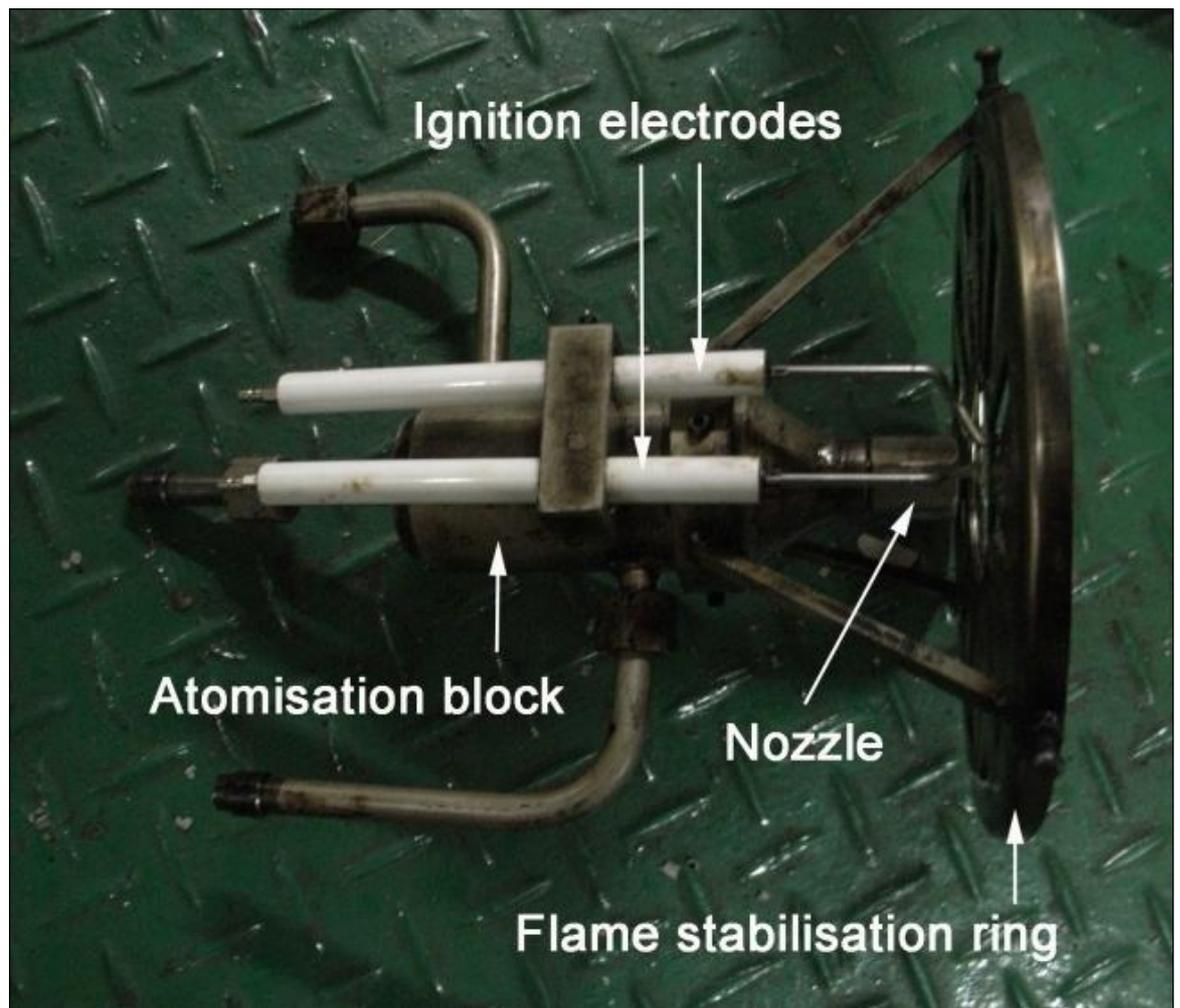
Figure 4: Oil firing unit burner

The burner (Figure 4) is fitted inside the oil firing unit at the boiler furnace opening. The burner consists of an atomiser block, which holds a single fuel nozzle, to which a flame stabilisation ring and a pair of ignition electrodes are attached.
