## **Service Bulletin**

**RTA-26**

**Technical Information to all the Owners  
of Sulzer RTA 58, 68, 76 and 84 Type Engines  
with WATERCOOLED PISTONS**

## **Loss of Material on Piston Crowns due to High Temperature Corrosion and Erosion**

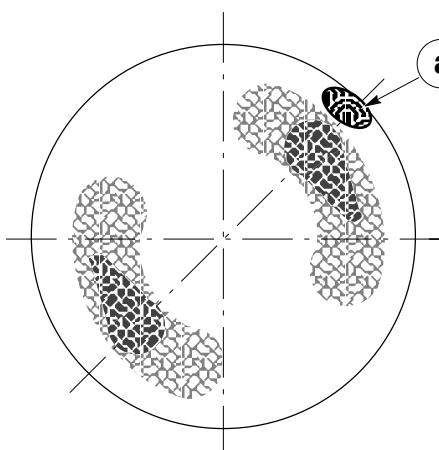
2 Fuel Injectors / Cyl.

Pattern on piston crown if both fuel injectors are in poor condition or equipped with nozzle tips with incorrect specification.

(a) Deep spots of material loss caused by dribbling fuel injection nozzles.

As we pointed out in paragraph 1.A. it is of major importance that the fuel injector valves are kept in a good state of repair to avoid excessive loss of material on piston crowns.

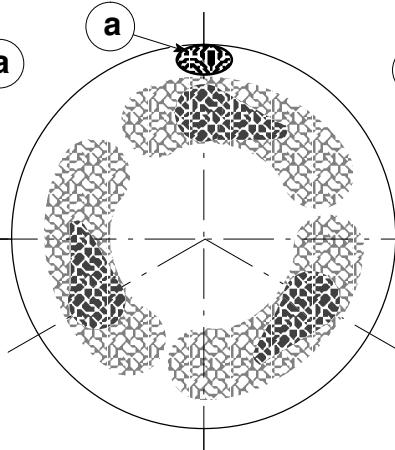
3 Fuel Injectors / Cyl.

Pattern on piston crown if all three fuel injectors are in poor condition or equipped with nozzle tips with incorrect specification.

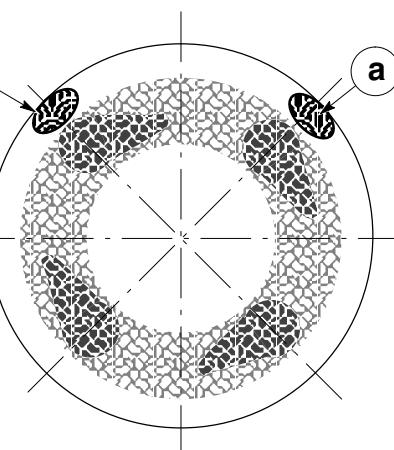
4 Fuel Injectors / Cyl.

Pattern on piston crown if all four fuel injectors are in poor condition or equipped with nozzle tips with incorrect specification.

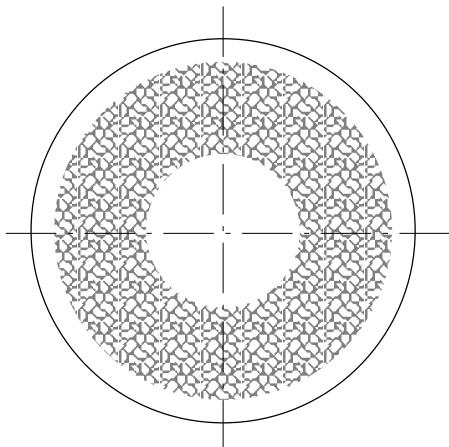
**Pattern:** So called "paving stone structure" / "elephant skin" over a large part / or smaller parts of the combustion surface of the piston crown has been observed. Such a morphology is typical for the described loss of material.

1. Piston cooling bores are covered either with scale and/or oily sludge due to insufficient piston cooling water condition.  
(1mm deposit on the inside of the cooling water bores can cause a temperature increase of up to 200°C on the combustion space surface of the piston crown.)
2. Lack of scavenge air, due to dirty air filter, compressor wheel and diffuser of the turbocharger, contaminated aircooler, or a dirty exhaust gas boiler or silencer.

If any abnormal amount of loss of material is discovered the piston crown must be removed and the cooling space must be inspected carefully and if there is any scale and/or oily sludge discovered then the origin of same must be investigated and the necessary steps taken to avoid any further chance for contamination of the piston cooling system.

However, should the loss of material be caused by overheating due to lack of scavenging air it is strongly recommended to investigate the matter until the true origin of the problem which has lead to this situation is found and taken care off (hints on possible trouble spots can be found in para B. 2.).

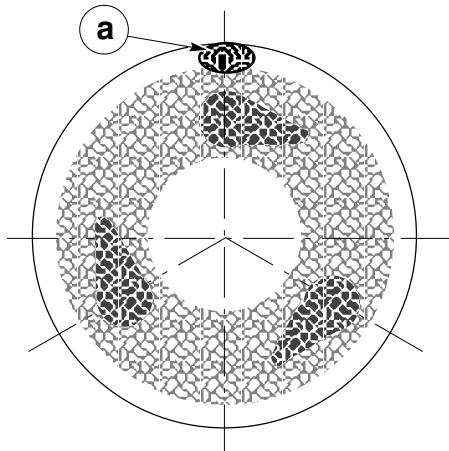
Drawn for engines with  
3 fuel injectors / cyl.

**Pattern on piston crown if all three fuel injectors are in poor condition or fitted with a nozzle tip with an incorrect specification with one of them dribbling (a).**  
In addition there are some signs of impaired piston cooling originating from a source mentioned in paragraph B.1. and B.2. or a combination thereof influencing the temperature of the combustion space surface of the piston crown.

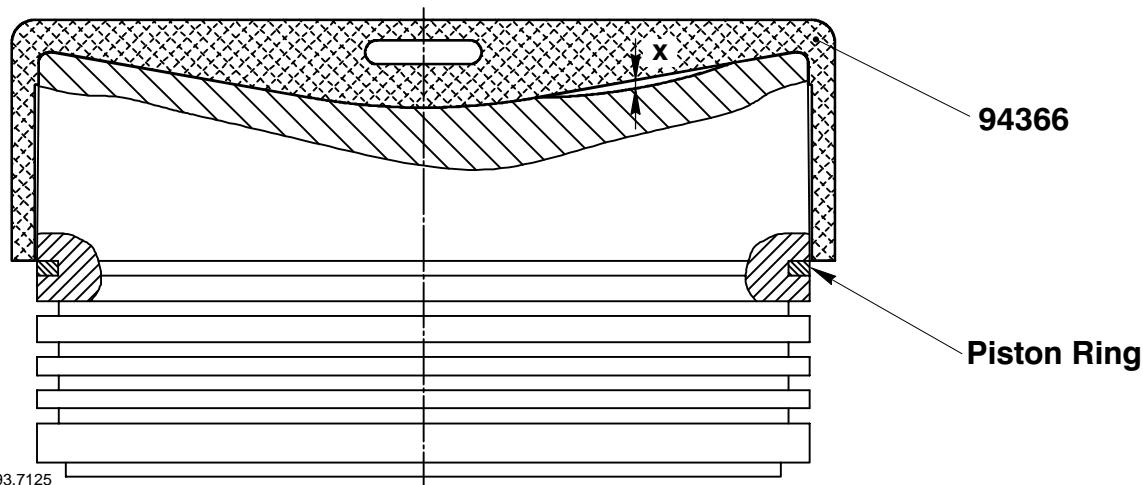
### **Checking the Piston Crown for Loss of Material**

ENGINE TYPE	RTA 58	RTA 68	RTA 76	RTA 84
Wear Limit "x"	8 mm	8 mm	9 mm	10 mm

**Piston crowns with wastage exceeding the above limits "x" can be sent to specialized firms for reconditioning.**

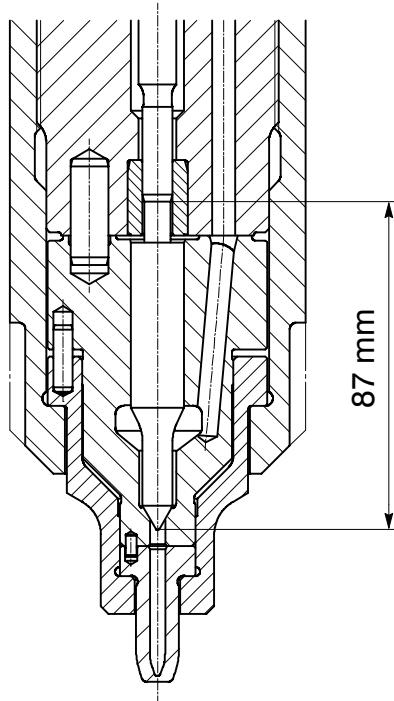
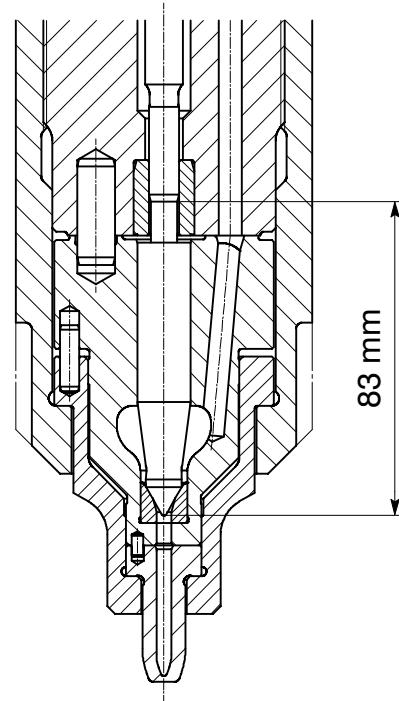
## 2P - NOZZLES FOR RTA ENGINES

Fuel nozzles with a needle length of 87 mm have a body which has only a case hardened integrated needle seat, whereas the correct nozzle body to be used with the shrunk-in through hardened needle seat has a needle with a length of 83 mm only. The correct fuel injection parts suitable for your engine can be obtained from:

To minimize the loss of material on the piston crown it is essential to use **only fuel nozzle tips with the correct specification** and we also recommend to use **only nozzle bodies with the through hardened seat** (please refer to "Execution B" on sketch above) to prolong the time between overhaul and increase the components serviceability.

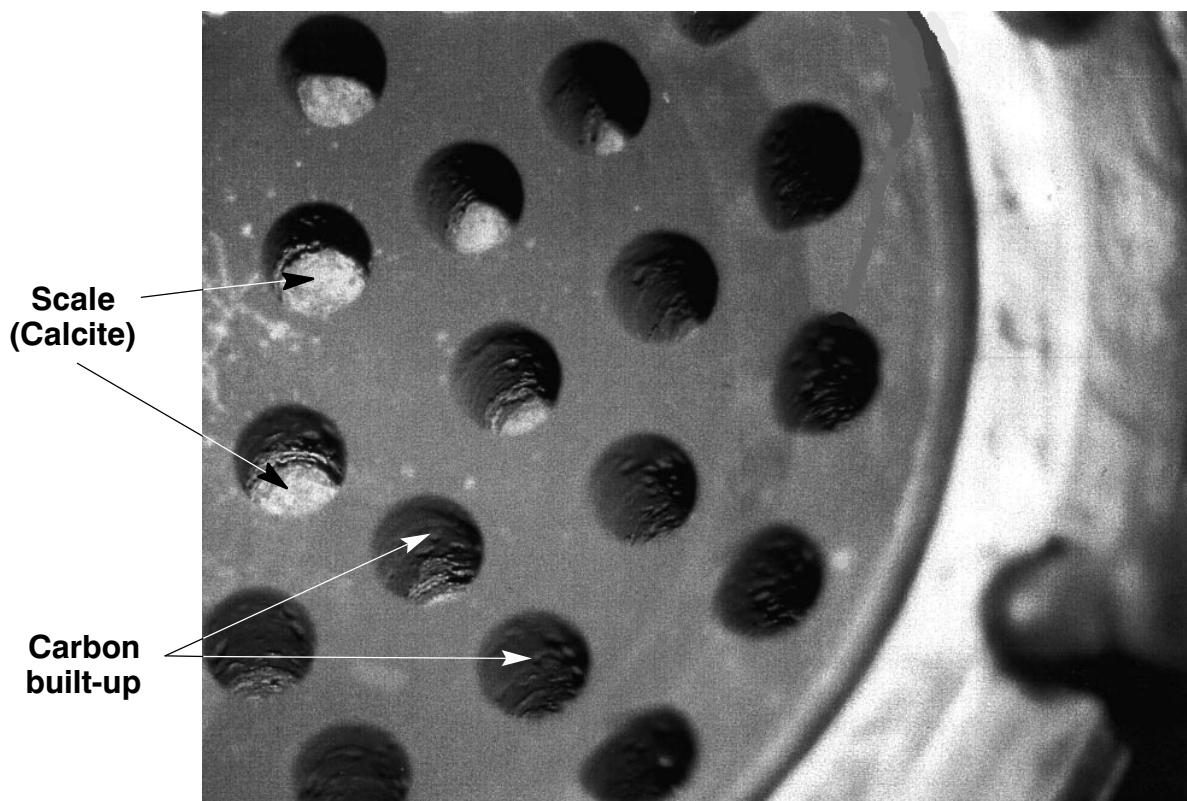
### Contamination of Cooling Bores in Piston Crown

If a pattern according to paragraph 1.B. or a combination of 1.A. and 1.B. is recognized then it is necessary to investigate the piston cooling system for its efficiency. The piston cooling water treatment plant may not work properly thus some of the sediments are causing either calcite and/or carbon deposits in the cooling bores of the piston crown (please refer to the picture of contaminated cooling bores below).

Contamination of the piston cooling system is mainly caused by oil and combustion residues which enter the cooling system and, if the layout of the system does not allow to separate them properly from the piston cooling water, they will eventually lead to contamination and forming of scale as can be seen on the picture above.

To clean the scale off the cooling bores it is necessary **to sandblast the internal of the piston crown**. A good efficient medium for the sandblasting is fine corundum grit. Chemical removal of the scale is **not sufficient** enough, gives **unsatisfactory results** and in addition may also be an **environmental hazard**.
