Service Bulletin

RTA-46

Technical Information to all Owners / Operators
of Sulzer RTA “-8 and -2 Series” Engines

CRACKS IN COLUMN

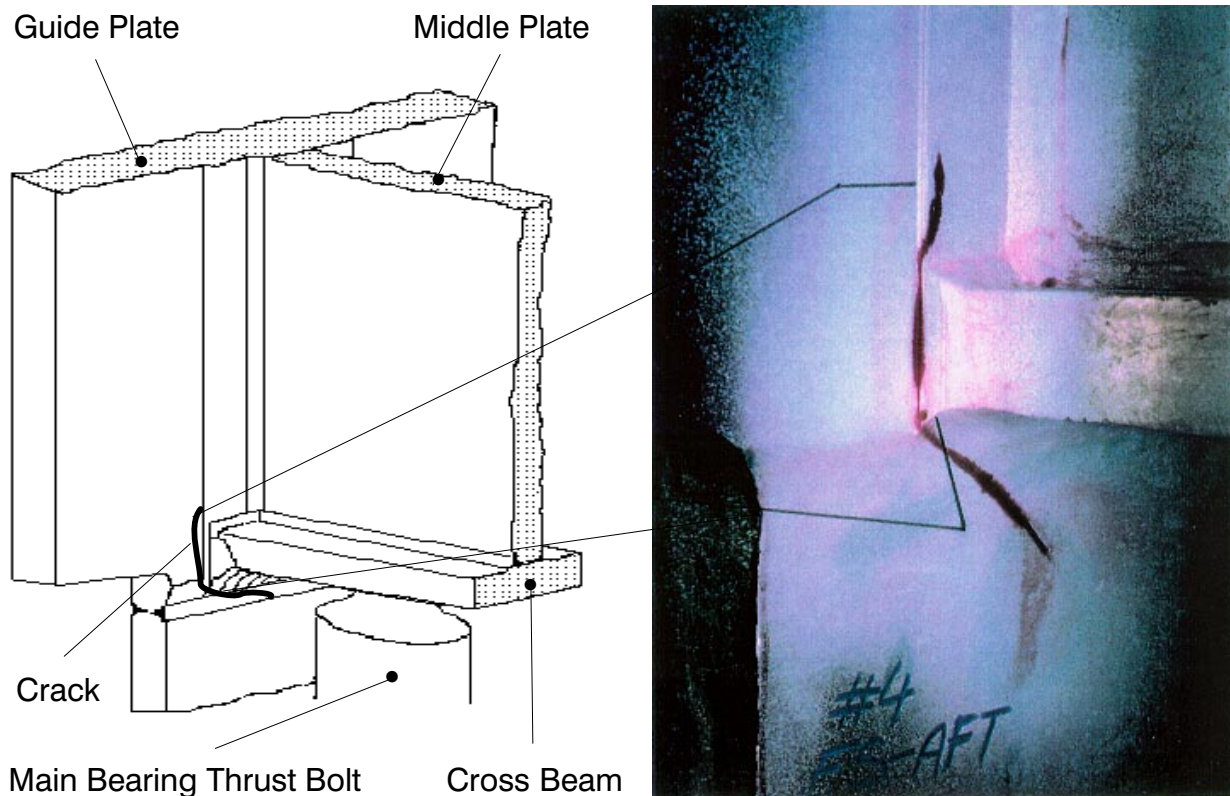
Fig. 1 Crack in the Corner of the Cross Beam

- In the corner of the cross beam for the thrust bolts and the guide plate (rail) [RTA 84, RTA 62, RTA 84M] [Fig. 1](#)
- In the welding seam between stiffening rib and guide plate (rail) [RTA 62, RTA 72, RTA 84M] [Fig. 2](#)
- In the welding seam between guide plate (rail) and transverse plate [RTA 76, RTA 84] [Fig. 3](#)
- In the vertical weld of the guide plate / middle plate on the gear column [RTA 76, RTA 84, RTA 84M, RTA 62, RTA 72] [Fig. 4](#)

5.4. Crack at the Corner of the Cross Beam (Fig. 1)

Cracks were observed in the corner of the cross beam for the thrust bolts and the guide plates.

- A repair can be scheduled for the next drydocking or long loading / discharging period. However, the engine must be immobilized for the repair purpose.
- The VIT must be deactivated
- Normally no restrictions for load or speed

If a crack is found in the corner of the cross beam for the thrust bolts and the guide plate, it is advisable to plan a repair and observe the cracked area closely, to prevent further damage (extension of crack) to the guide plate / cross beam area.

6.1. Repair on the Cross Beam of Monoblock Column (Ear Solution)

- Removing of the crack by cutting out the affected area, grinding and weld stiffening ribs (Ear Solution, Fig. 5).

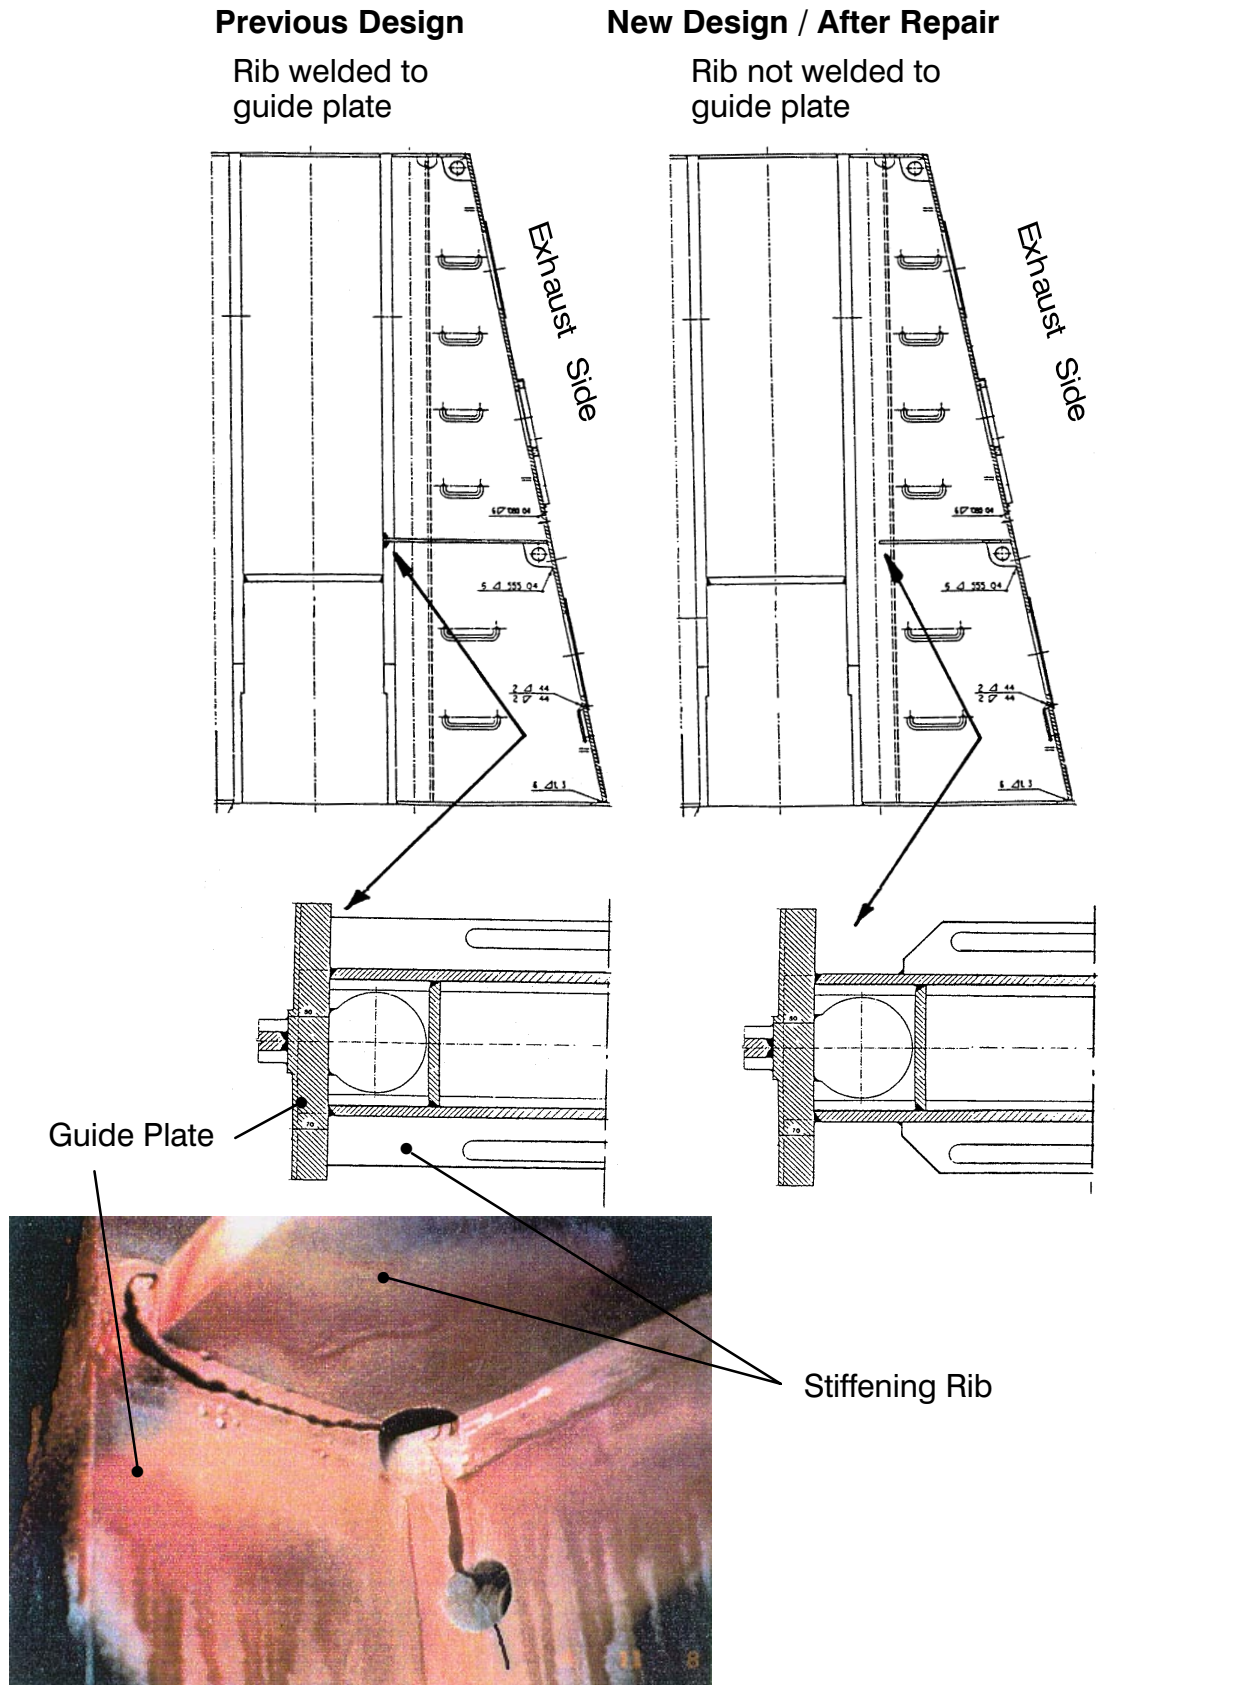
Fig. 2 Crack in the Welding Seam between Stiffening Rib and Guide Plate

5.5. Crack at the Stiffening Rib and Guide Plate (Fig. 2 on page 4)

Cracks could appear in the welding seam between the stiffening rib and the guide plate. However, this could only happen on the previous execution were the stiffening rib is still welded to the guide plate.

A crack in the welding seam between the stiffening rib and the guide plate would also lead gradually to a reduction in the clearance for the crosshead guide shoes, causing damage to the whitemental layer of the crosshead guide shoes.

- Crack in the vertical welding seam must be repaired as soon as possible otherwise a crack propagation towards the transverse plate will occur
- The VIT must be deactivated
- Normally no restrictions for load or speed
- Condition of the guide shoes whitemetal layer must be inspected more frequently

6.2. Repair on the Stiffening Rib

These repair method will prevent the crack propagation to the transversal plate.

- Stiffening rib to the guide plate stop hole to be drilled (only temporary solution Fig. 6).
- Stiffening rib to be shortened (Fig. 6).

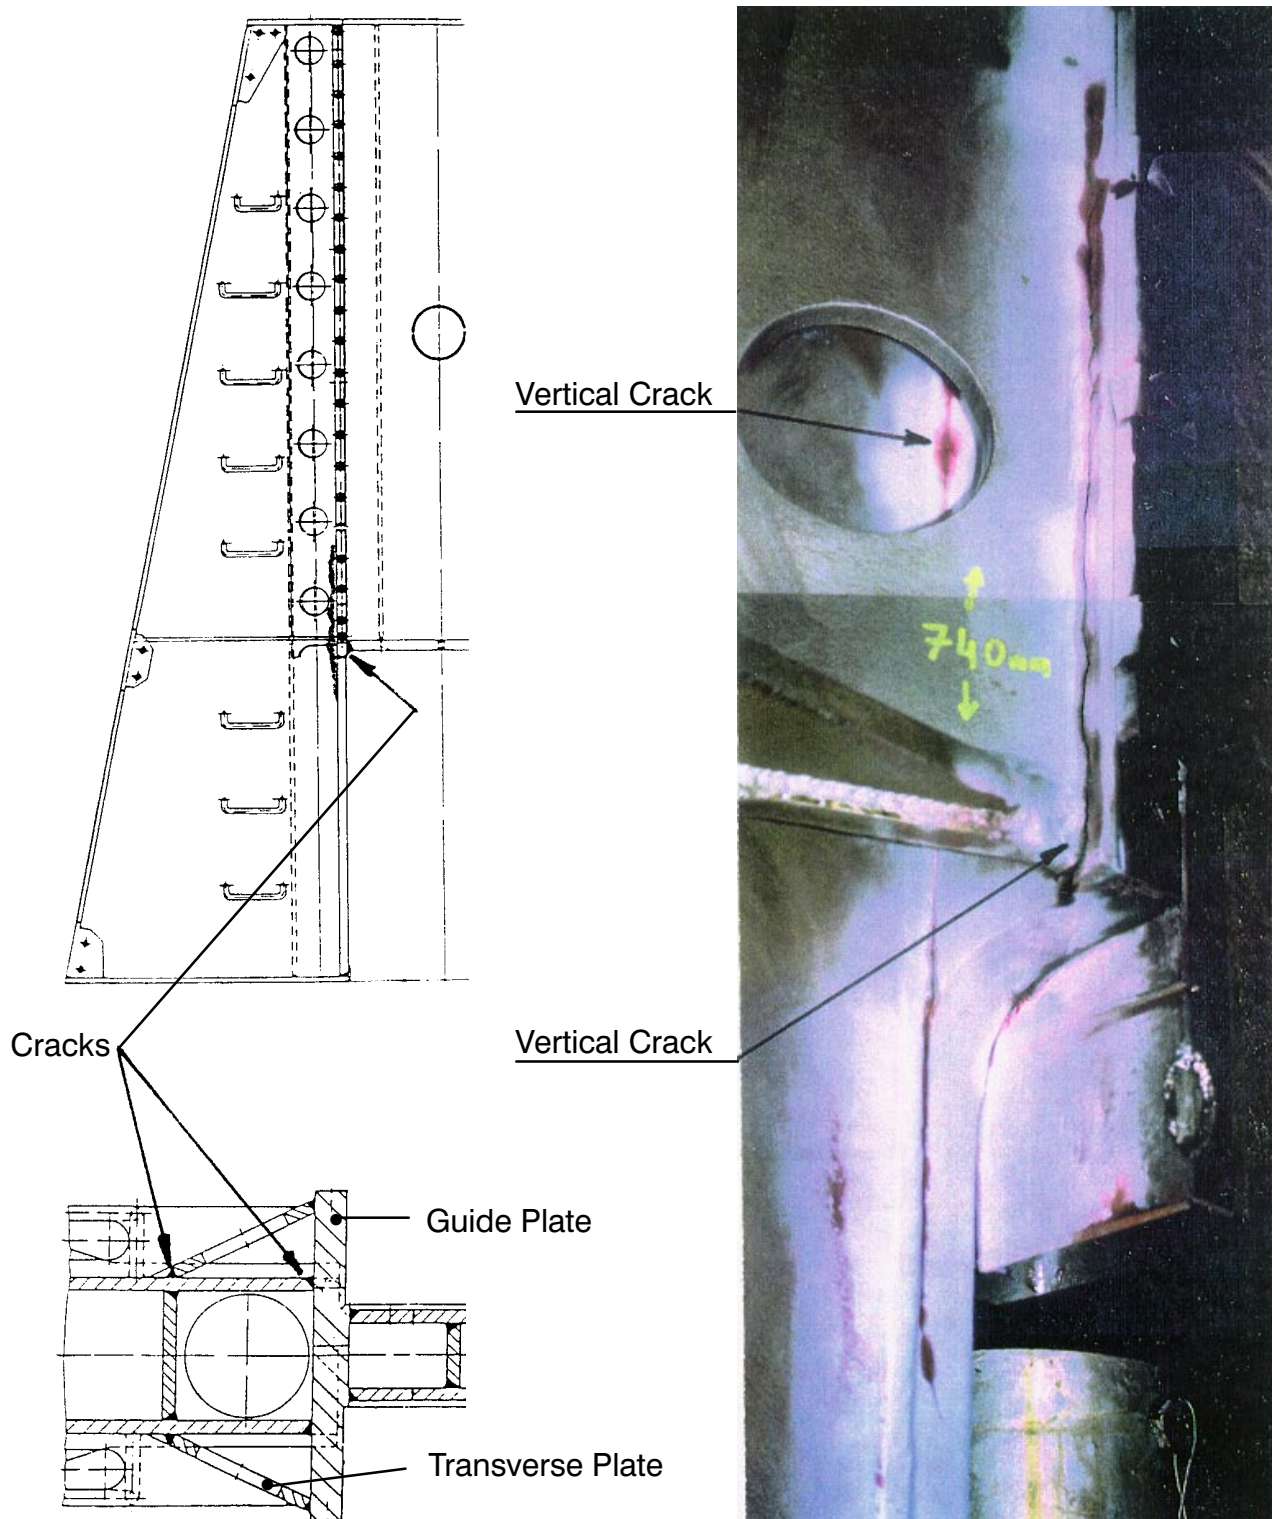
Fig. 3 Vertical Cracks in the Welding Seam between Guide Plate and Transverse Plate

5.6. Crack at the Guide Plate and Transverse Plate (Fig. 3)

On some of the RTA “-8 Series “ engines, vertical cracks in the welding seam between the guide plate and the transverse plate could be found. This is a serious case and should be repaired as soon as possible.

A vertical crack in the welding seam between the guide plate and the transverse plate would also lead gradually to a reduction in the clearance for the crosshead guide shoes, causing damage to the whitemetal layer of the crosshead guide shoes.

- Crack in the welding seam must be repaired as soon as possible
Negative running clearances between the guide shoe and unloaded guide rail due to expanded open crack
- The VIT must be deactivated
- Normally no restrictions for load or speed
- Condition of the guide shoes whitemental layer must be inspected more frequently

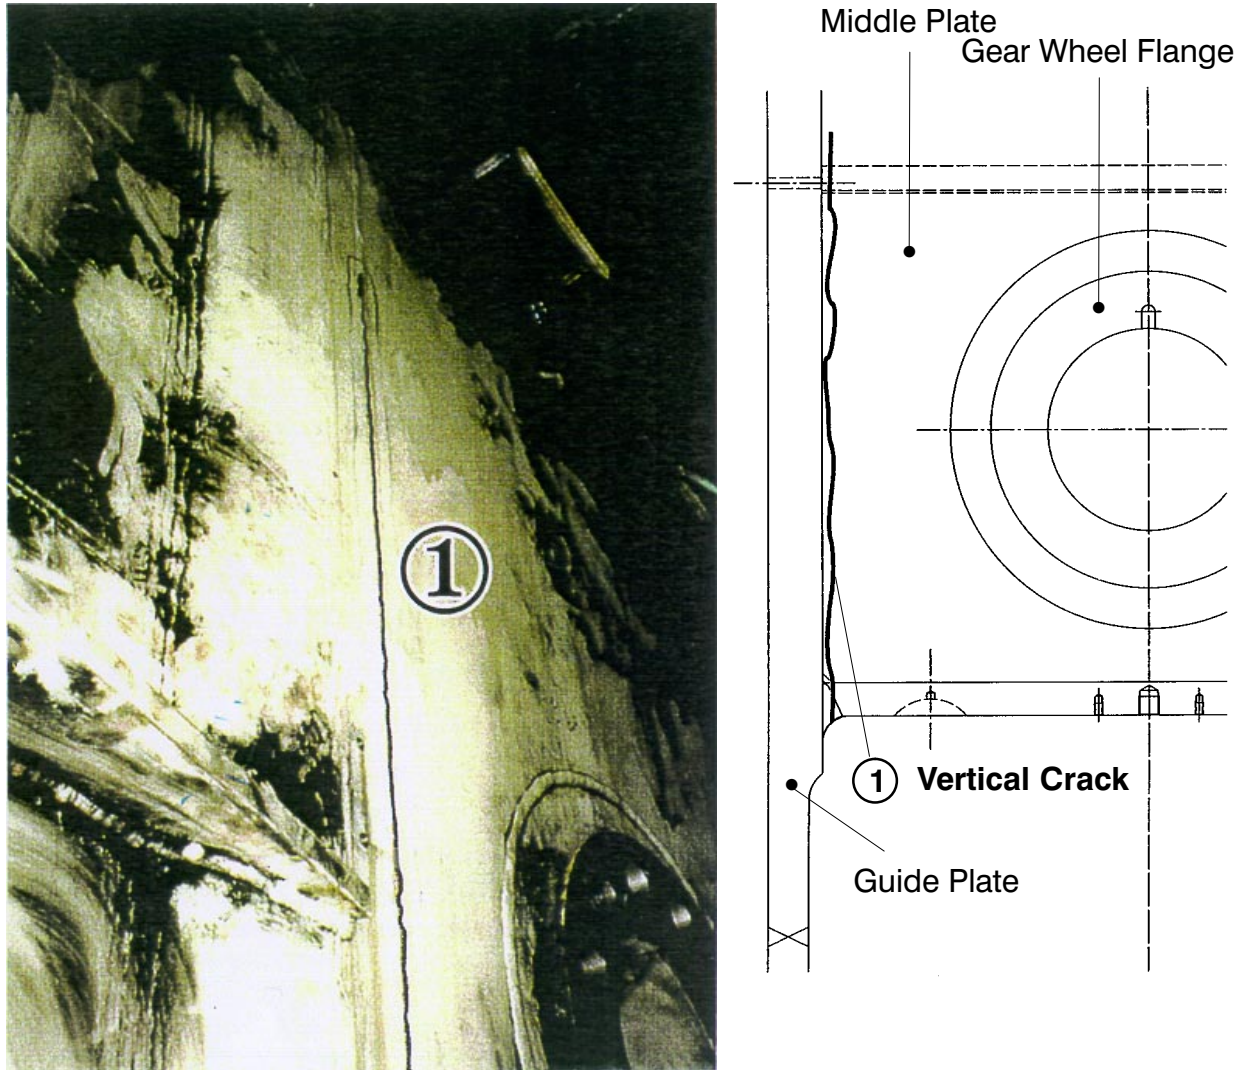
Fig. 4 Crack in the Gear Column

5.7. Crack at the Gear Column (Fig. 4)

Cracks were observed in the vertical weld of the guide plate / middle plate in the gear column. If the crack is far extended the gear wheels will show heavy overload pittings.

- Crack in the welding seam must be repaired very urgently
ATTENTION! Danger of break down of the gear train
- Restriction of power and speed must be considered

In this case an urgent repair is needed otherwise there is a danger of breakdown of the gear train.

6.3.2. Repair on Gear Column

This is a rather complicated and time consuming repair. Each case must be carefully inspected and an individual repair procedure plan must be made.

If the repair is not carefully carried out, especially the correct welding sequence, heavy distortion can be expected.

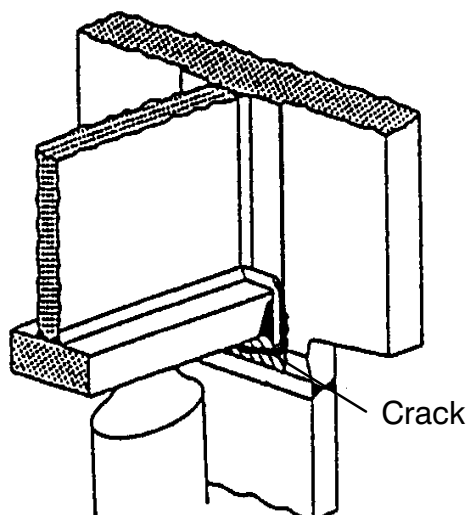
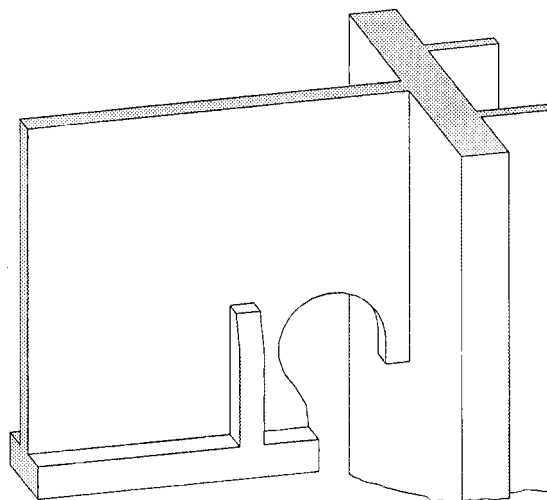
Fig. 5 Ear Solution Repair

Cross Beam with Crack in Transition Area

Ear Solution

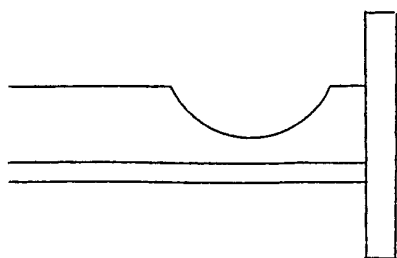
Stiffening rib to be cut-out

Not recommended, if cracks are found in these ribs to the guide plate.

Grind vertical weld in this area and dye-check for cracks

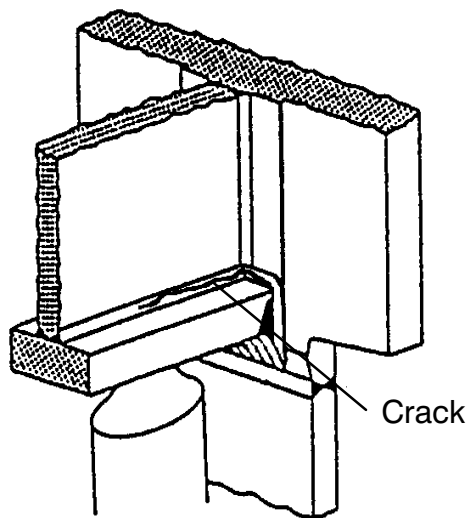
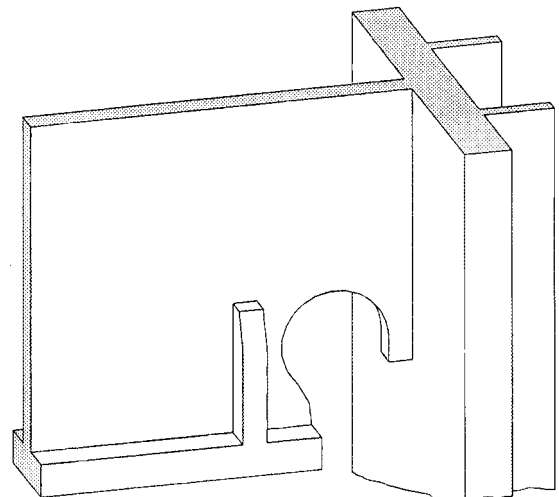
Fig. 7 Ear Solution Repair

Crack behind Cross Beam

- Removal and renewal of cross beam in order to have sufficient access for complete elimination of the crack(s). Welding in two additional stiffening ribs to the guide plates and the cross beam. The ribs are located between the two middle plates (Ear Solution, Fig. 7).

Note: *No stop holes should be drilled at the end of cracks, to avoid an even more expensive repair.*

Ear Solution
