Service Bulletin

RTA-54

Technical Information to all Owners / Operators
of Sulzer RTA Engines with electronic VIT

Electronic Variable Injection Timing Troubles and Remedies

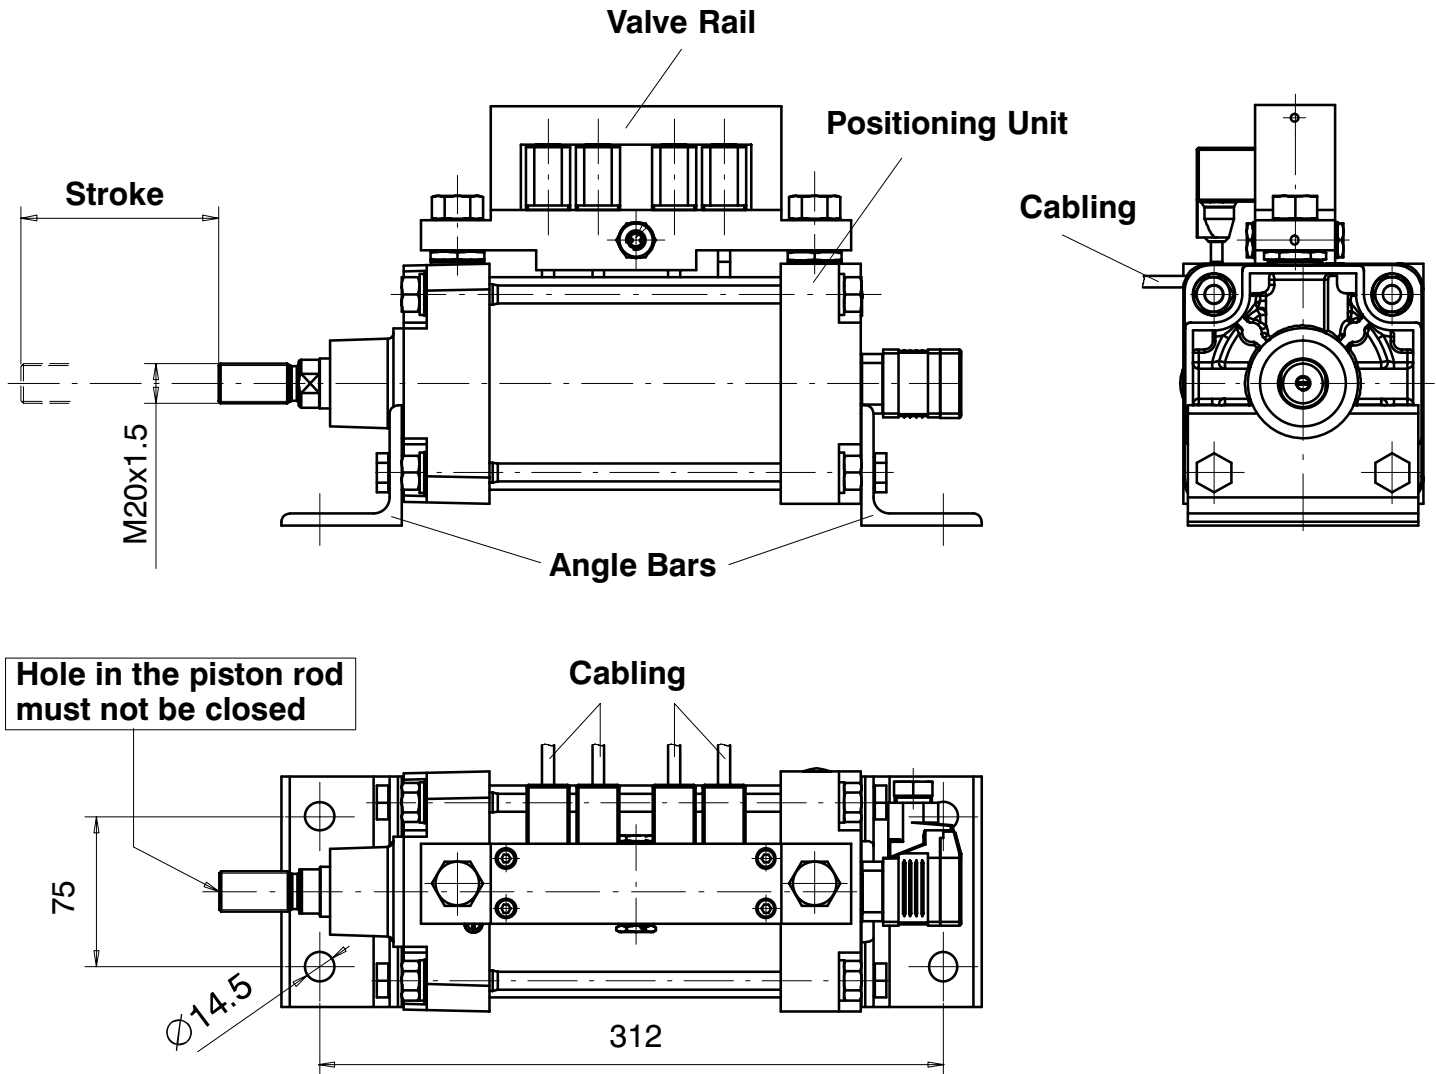
Fig. 1 Positioning Unit of the Electronic VIT

The investigations showed that the VIT positioning unit is moving in and out with each injection under the forces in the fuel injection pumps. This movement could have an amplitude of up to 1.5mm (peak-to-peak) and results in excessive wear on the positioner's feedback transmitter. In order to make the system robust against these small but frequent movements, that have to be accepted and must be considered normal in the present arrangement, a backlash of 2mm (peak-to-peak) has been introduced between the piston rod and the feedback potentiometer. The resulting loss in positioning accuracy is within the acceptable tolerance for the VIT system. In addition the solenoid valves were changed to a rigid design based on experience with sticking valves of the previous design.

The above mentioned improvements to the pneumatic positioning valves and the feedback transmitters have been developed in close co-operation with the manufacturer of the positioning unit and were integrated into the new product.

The new positioning unit is now also available for engines already in service.

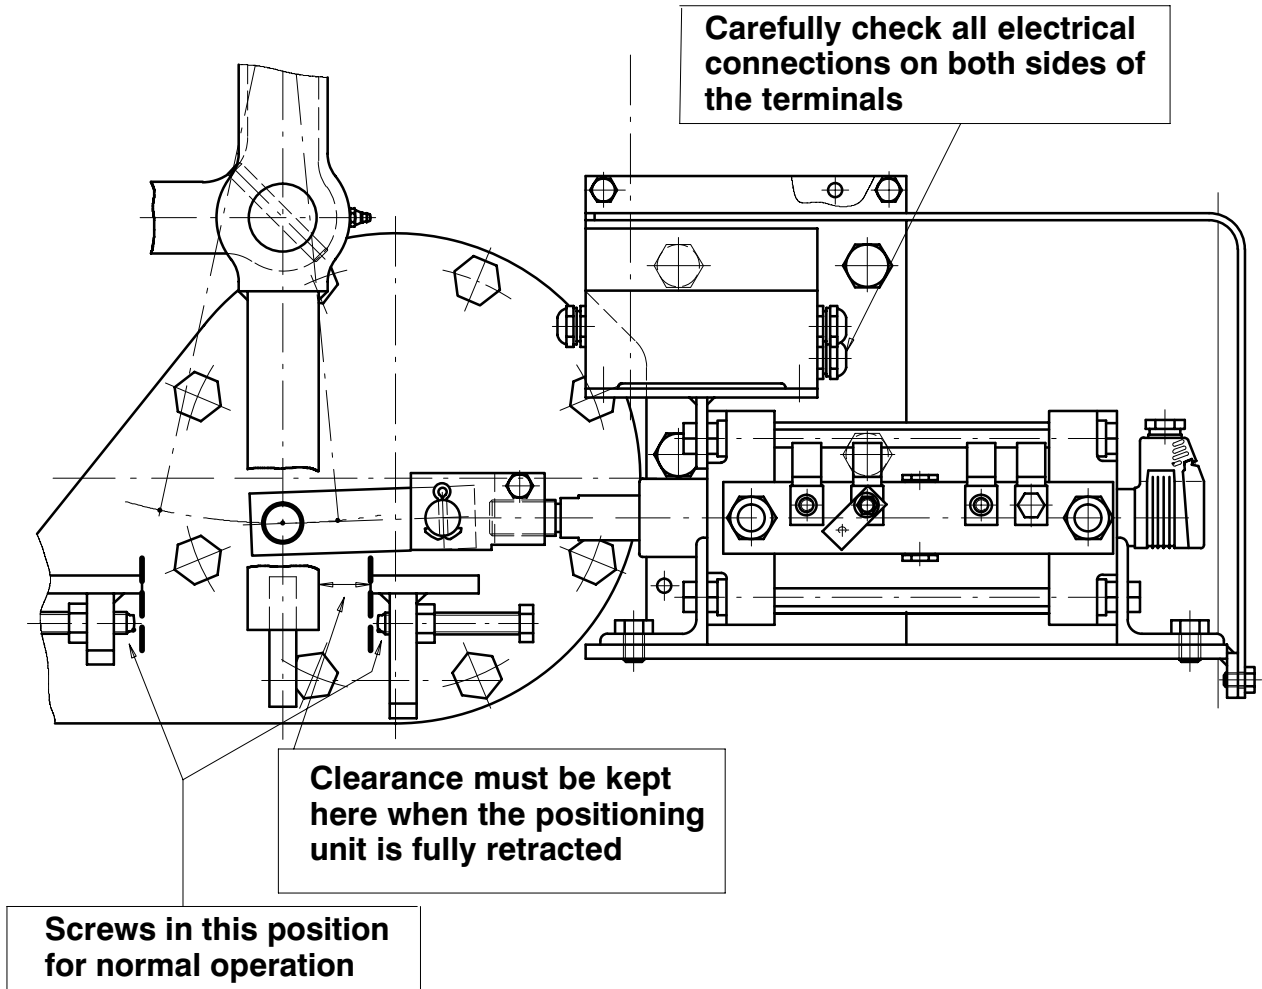
Fig. 4 Positioning Unit of the Electronic VIT

5. Electrical connections to be carefully checked as shown for example on [Figure 4](#) in the Service Bulletin Enclosure RTA–54/2.
Cases of open circuit have been found, particularly on rather stiff cabling and cable shoes used between the connecting box and VIT terminal box.

4. When fitting or refitting the VIT positioning unit the clearances and alignment shown for example in [Figure 4](#) and [5](#) in the Service Bulletin Enclosure RTA–54/2 must be checked and if necessary corrected.
If there is no clearance between the minimum stop plate and the linkage with the cylinder in the fully retracted position, then the stop plate must be ground until clearance is achieved.
