Service Letter

No: SL89-251/UM
May, 1989

MC-Engines
Camshaft Lubrication System

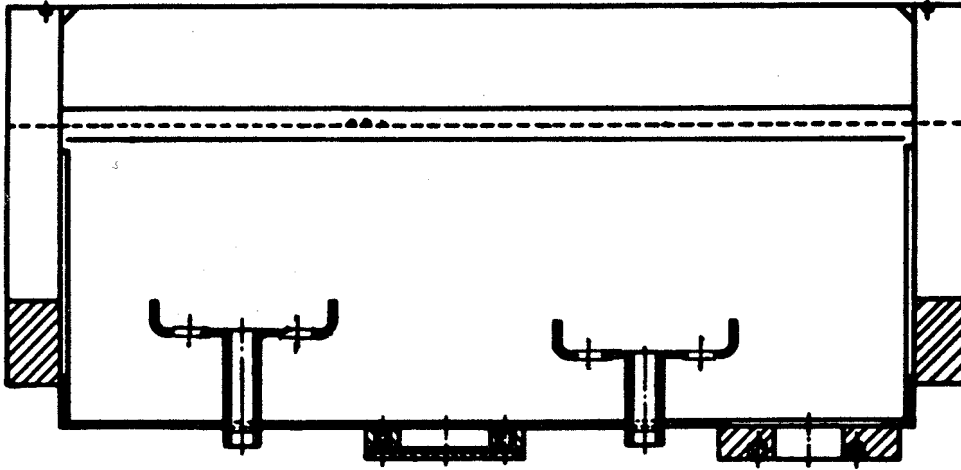
OIL PAN - welded execution

During operation of these engines, both the exhaust valve cams and fuel pump cams dip into an oil tray without a drain. The original intention with this design was to ensure a certain amount of lubrication in the event of lube oil failure.

However, we have experienced that these oil trays collect dirt and wear particles, which can deposit on the surfaces of cams and rollers. As no similar problems have been experienced on the smaller engine types, which are not equipped with such oil trays, we recommend that the oil trays be punctured as shown in Enclosures 1.a & 1.b or just removed.

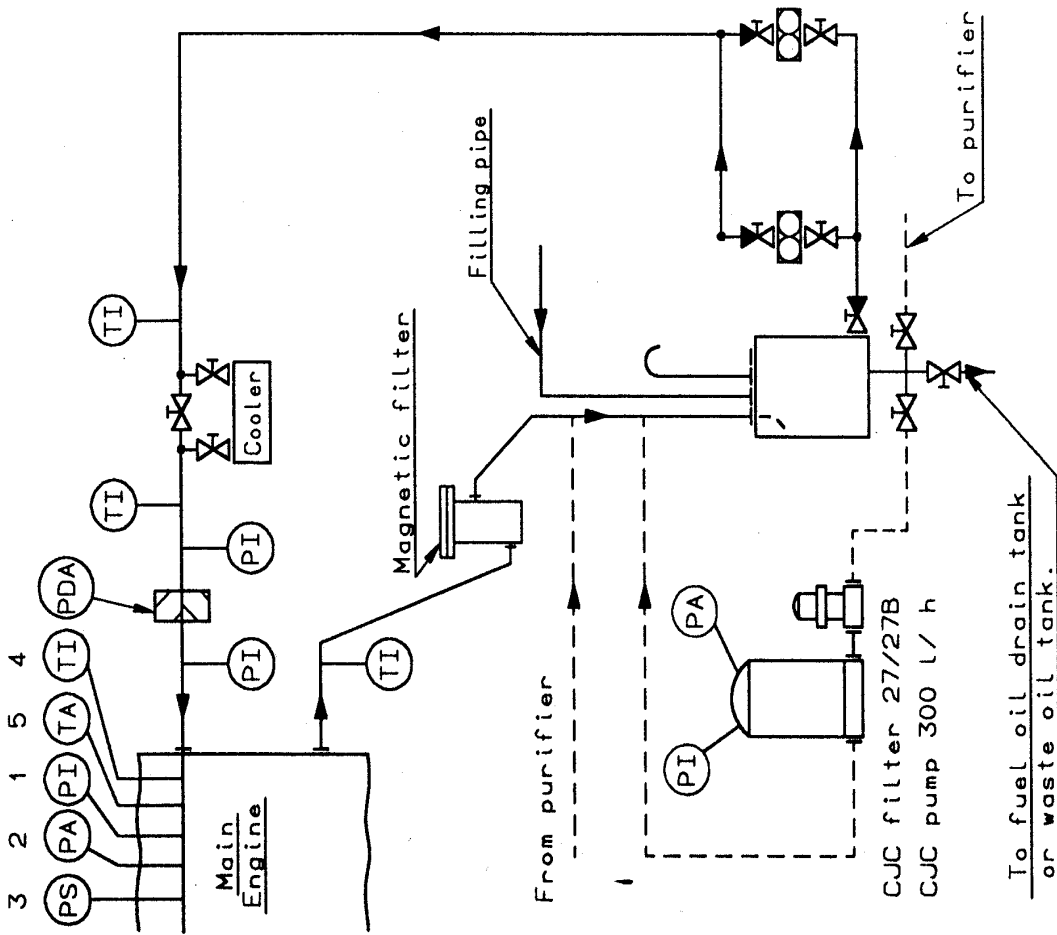
Camshaft Lub.oil system

The sequence of events leading to the breakdowns have not been fully clarified in all cases. In at least two cases malfunctioning lube oil filters allowed wear particles and parts of broken-down filter mesh to circulate in the camshaft lube oil system and in this way accelerated the wear process in all units, leading to the damage to roller guides, rollers and cams.

We draw your attention to the specified ranges for the camshaft lube oil pressure and temperature, see Enclosure 2. Operation outside the nominal values will provoke a risk of reduced safety of the lubrication. The installed full-flow filter should be inspected at regular intervals.

To prevent magnetic wear particles circulating in the camshaft oil system, we recommend that a magnetic filter is installed as shown in the enclosed schematic drawing No. 786262-9, Enclosure 2. The magnetic filter should be checked and cleaned regularly.

In addition to this, we recommend to arrange for by-pass filtration of the lube oil, as shown in drawing No. 786262-9, Enclosure 2, in the form of a separate fine filter of the CJC type, or similar. The filter should comprise a positive displacement pump to secure a fixed flow.

Further to this, it is recommended that an alarm device is installed for indicating both 'no differential pressure', and 'too large differential pressure' across the regular full-flow filter.
