Service Bulletin

RTA-50

Technical Information to all Owners / Operators
of Sulzer RTA Engines

Leakage Oil Collector in Air Spring System of Exhaust Valve

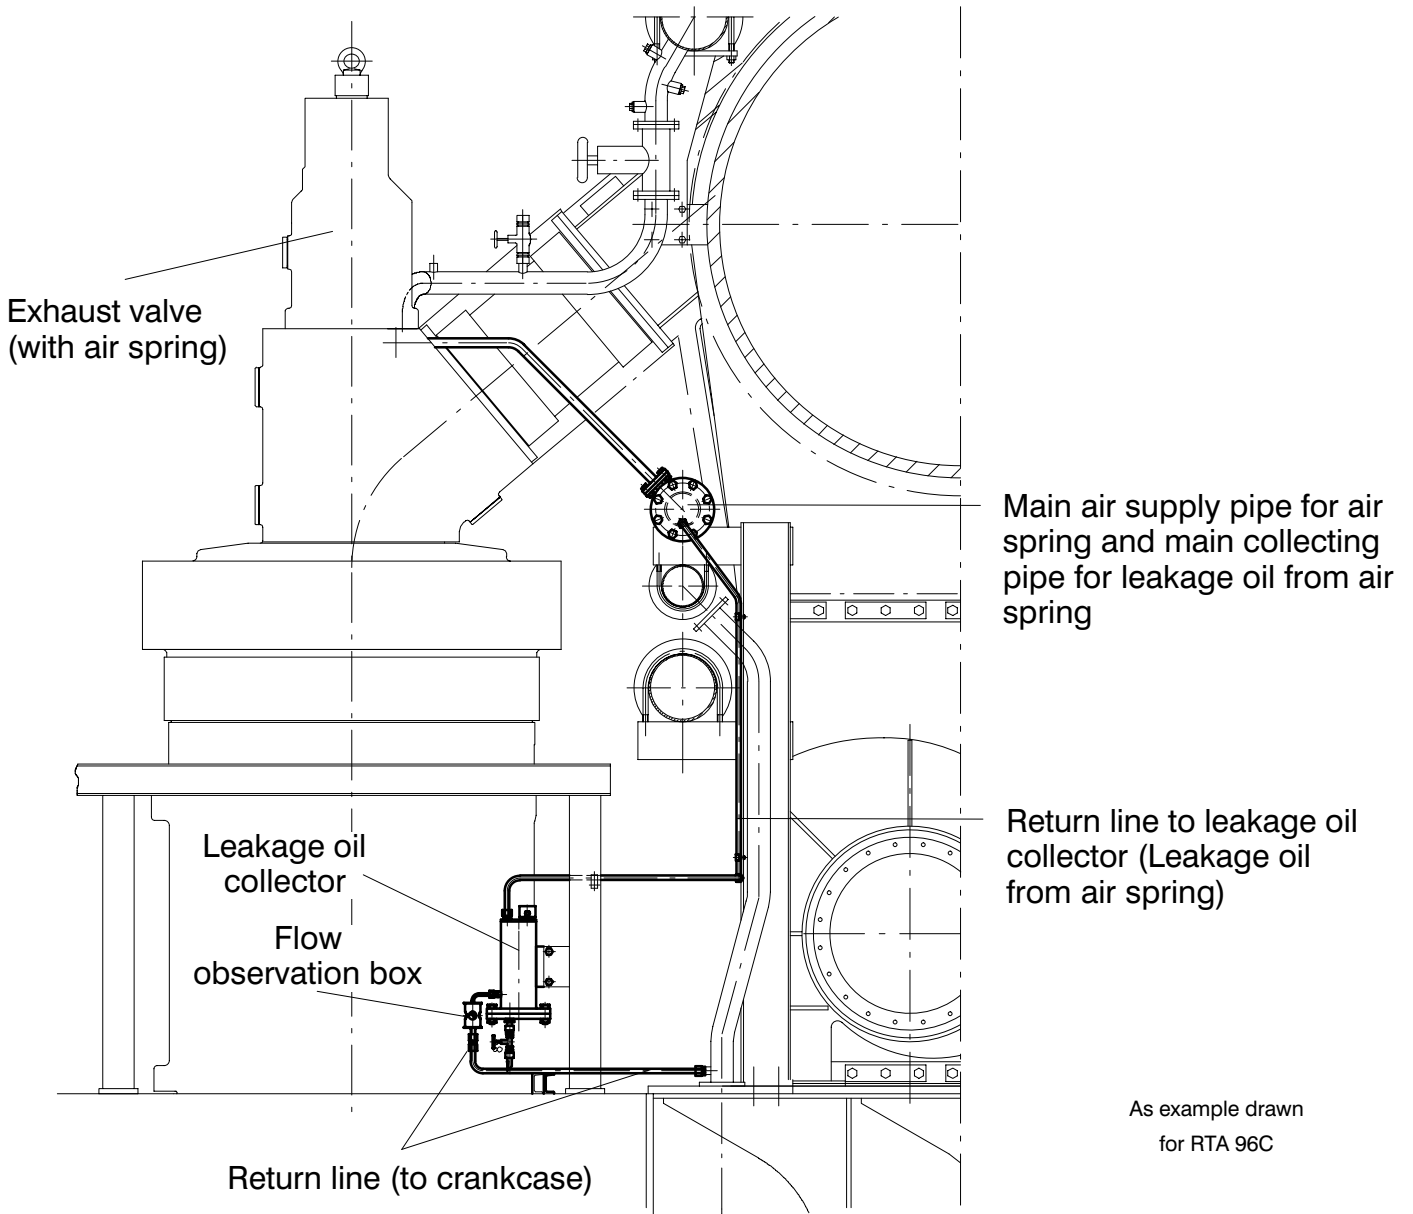
Fig. 1 Return line of Leakage Oil from Air Spring (Today's Design)

On engines built before late 1994 and those again built recently the return line is connected to the crankcase. The layout of the return line with its collector of the leakage oil from the air spring might be different from one engine series to another. However, the working mode is always the same. The figure below shows a return line with collector of a RTA 96C engine of the latest design. Please verify on your engine accordingly.

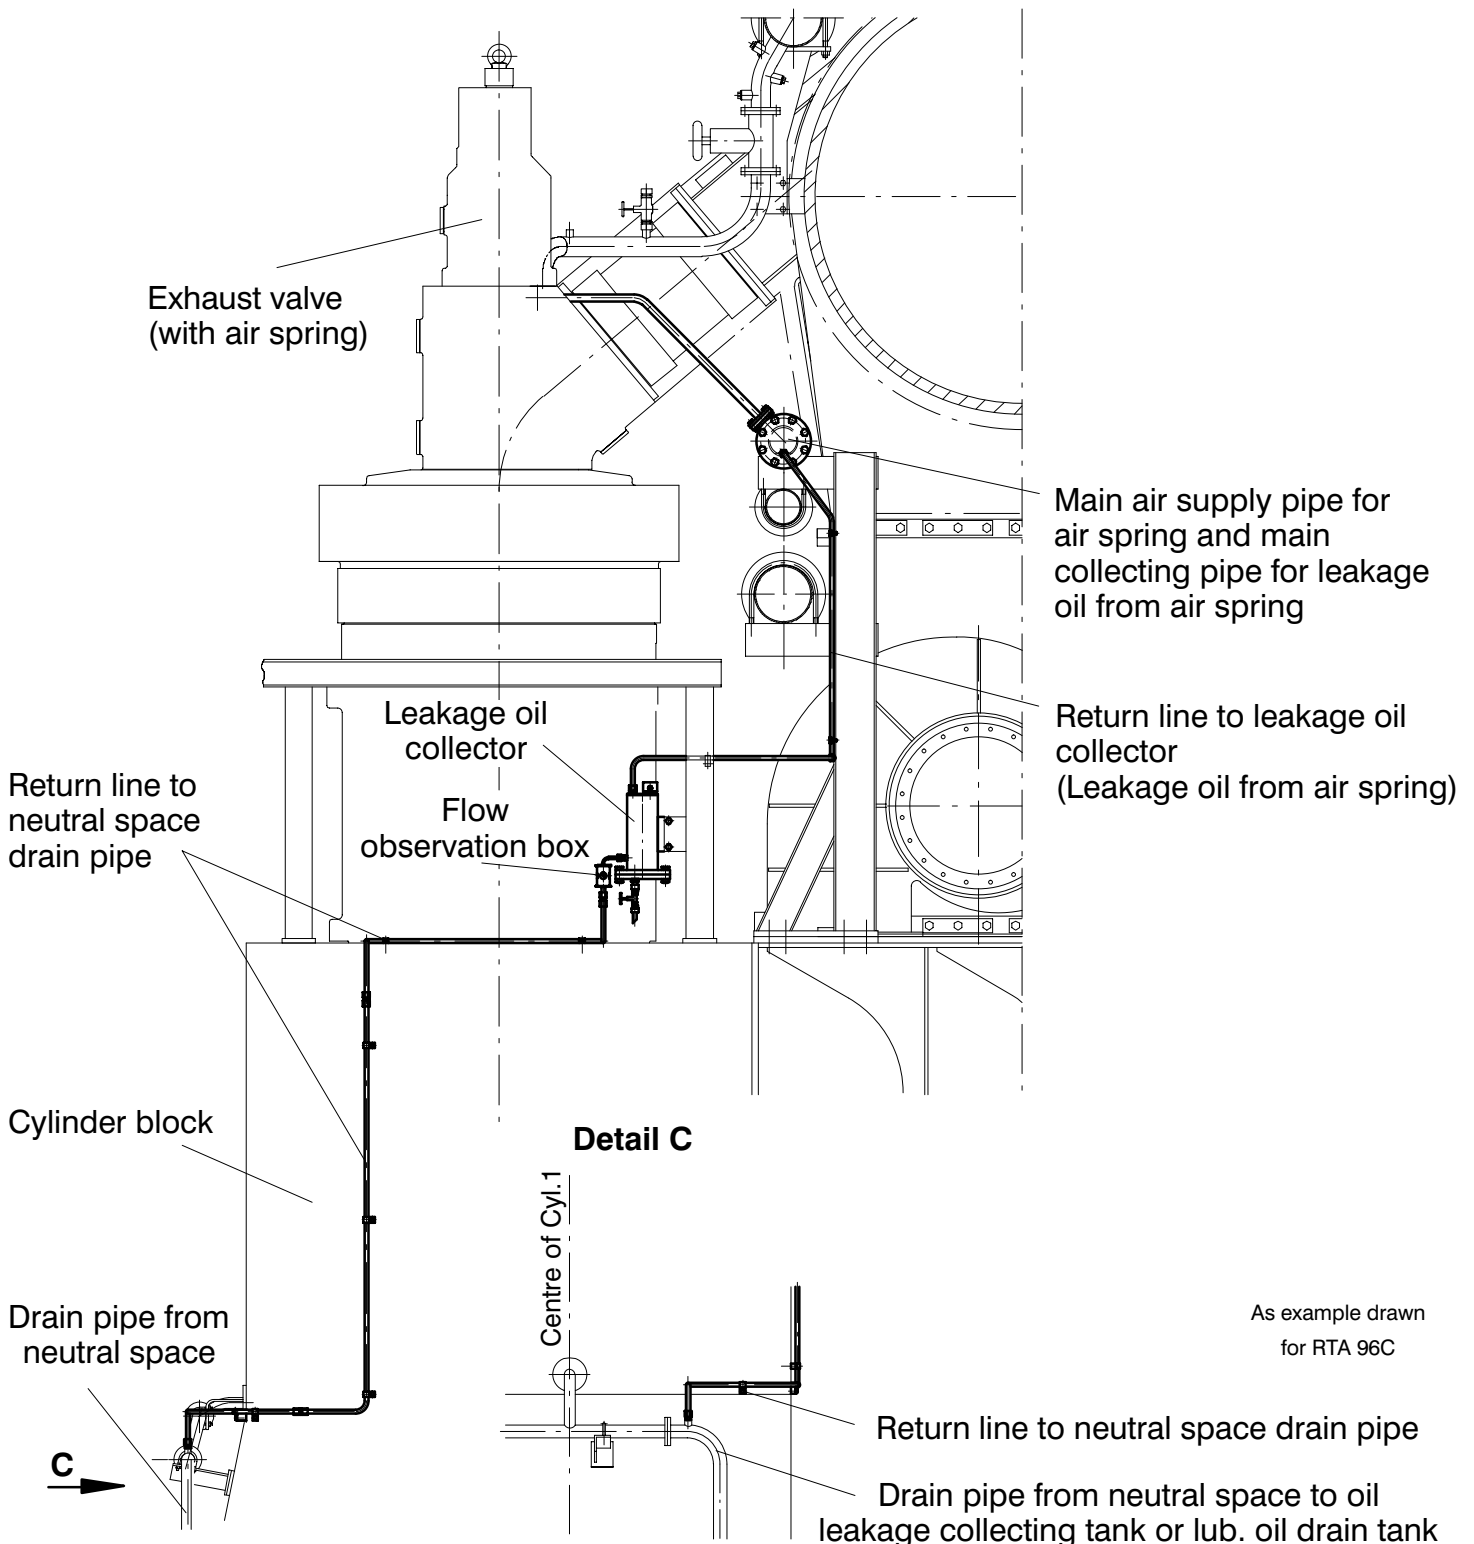
Fig. 2 Return line of Leakage Oil from Air Spring (Previous Design)

On engines built between late 1994 and late 1998 the return line was connected to the drain pipe from the neutral space of the piston rod stuffing boxes. The layout of the return line with its collector of the leakage oil from the air spring might be different from one engine series to another. However, the working mode of the leakage oil collector is always the same. The figure below shows a return line with collector of a RTA 96C engine of the previous design. Please verify on your engine accordingly.

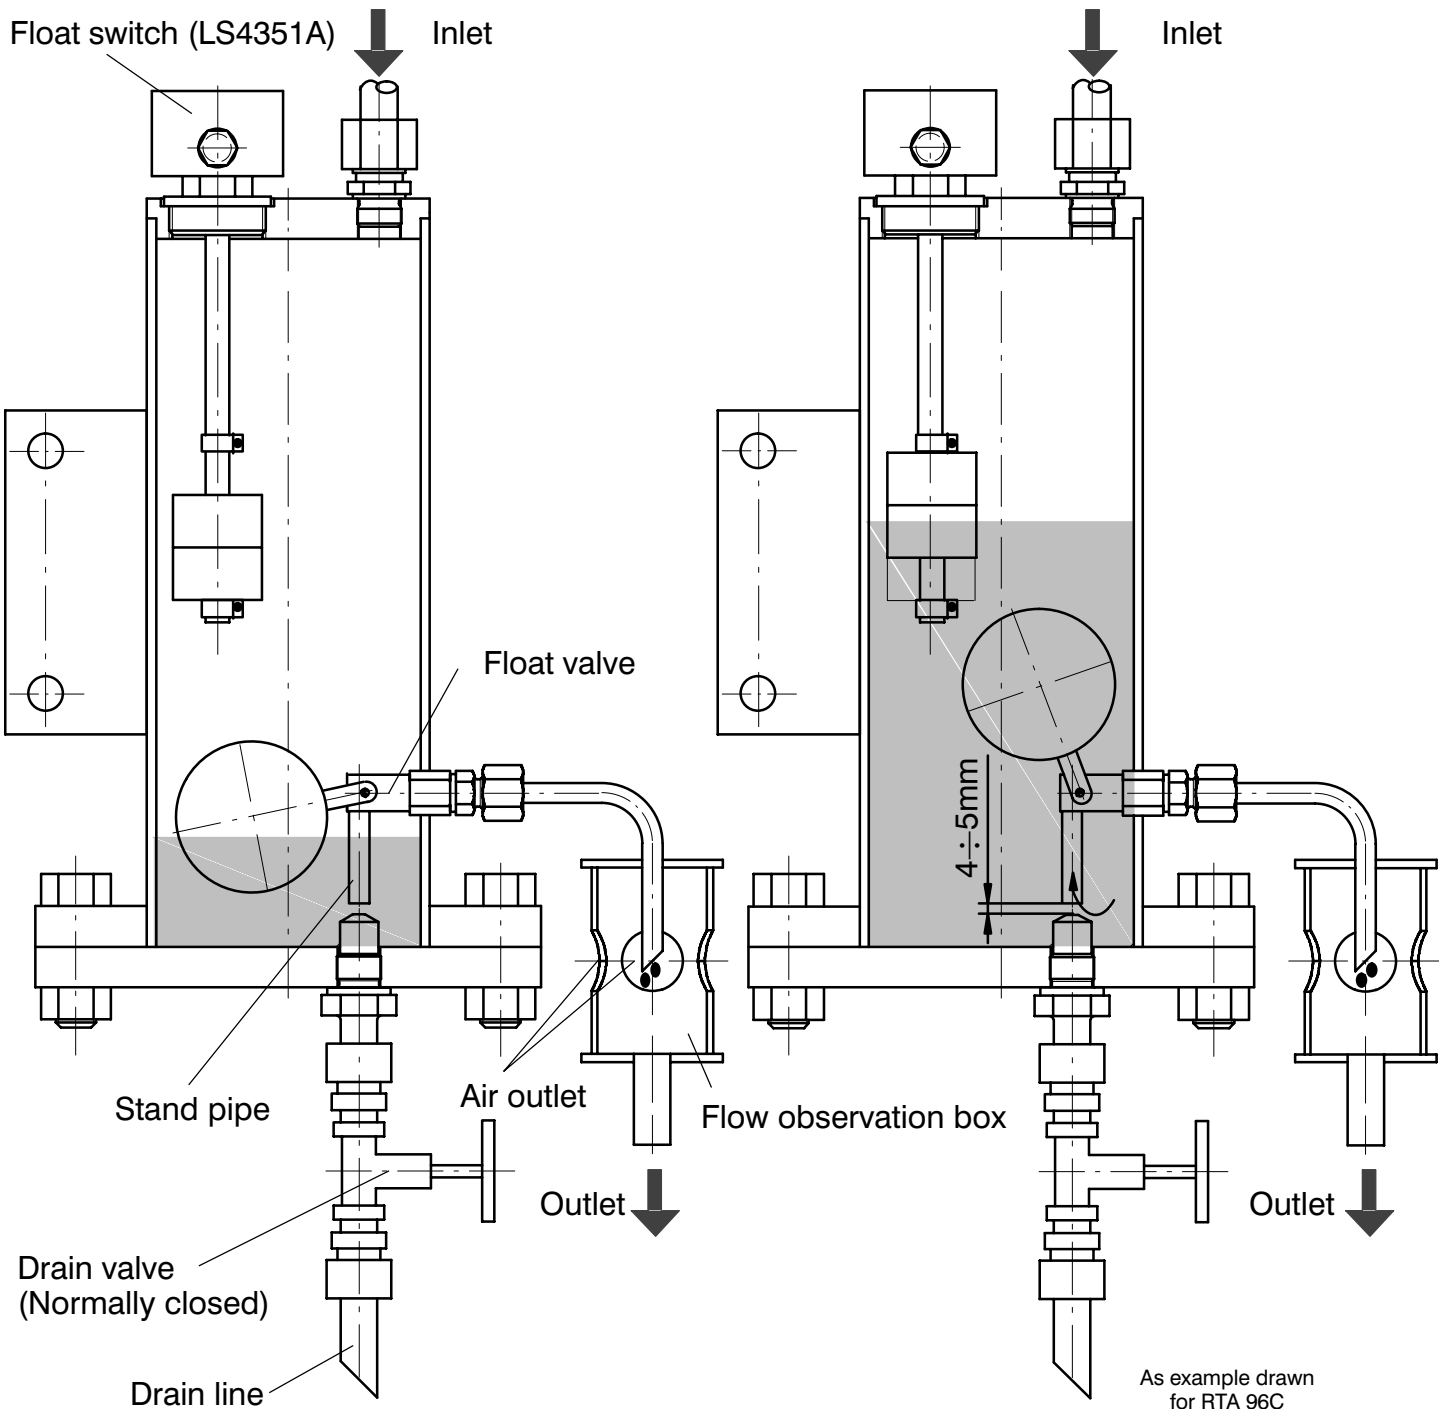
Fig. 3 Leakage Oil Collector

For an appropriate float control in the leakage oil collector the same is equipped with a float valve and a float switch. Under normal operating conditions the leakage oil collector is under pressure (about 7 bar air spring pressure) and any leakage oil is discharged by the float valve. The float switch activates a high level alarm if the level of the oil increases due to a possible malfunction of the float valve.

Normal Operation

High Level Alarm
 In case of a malfunction of the float valve

- Cross section of free discharge in the float valve is clogged due to particles.
- If the float valve is not correctly mounted (sloping position) within the collector, the free movement of the float ball is not guaranteed.

- A faulty weld seam on the float ball could lead to a malfunction of the float valve, because in that case the float ball will soon be filled up with oil.
- A wrong assembled float valve (Journal position of the float ball to the float valve) could lead to a total closed valve position.
- The cross section of the oil intake at the stand pipe of the float valve is too small due to a manufacturing fault. Normal clearance: $4 \div 5$ mm.

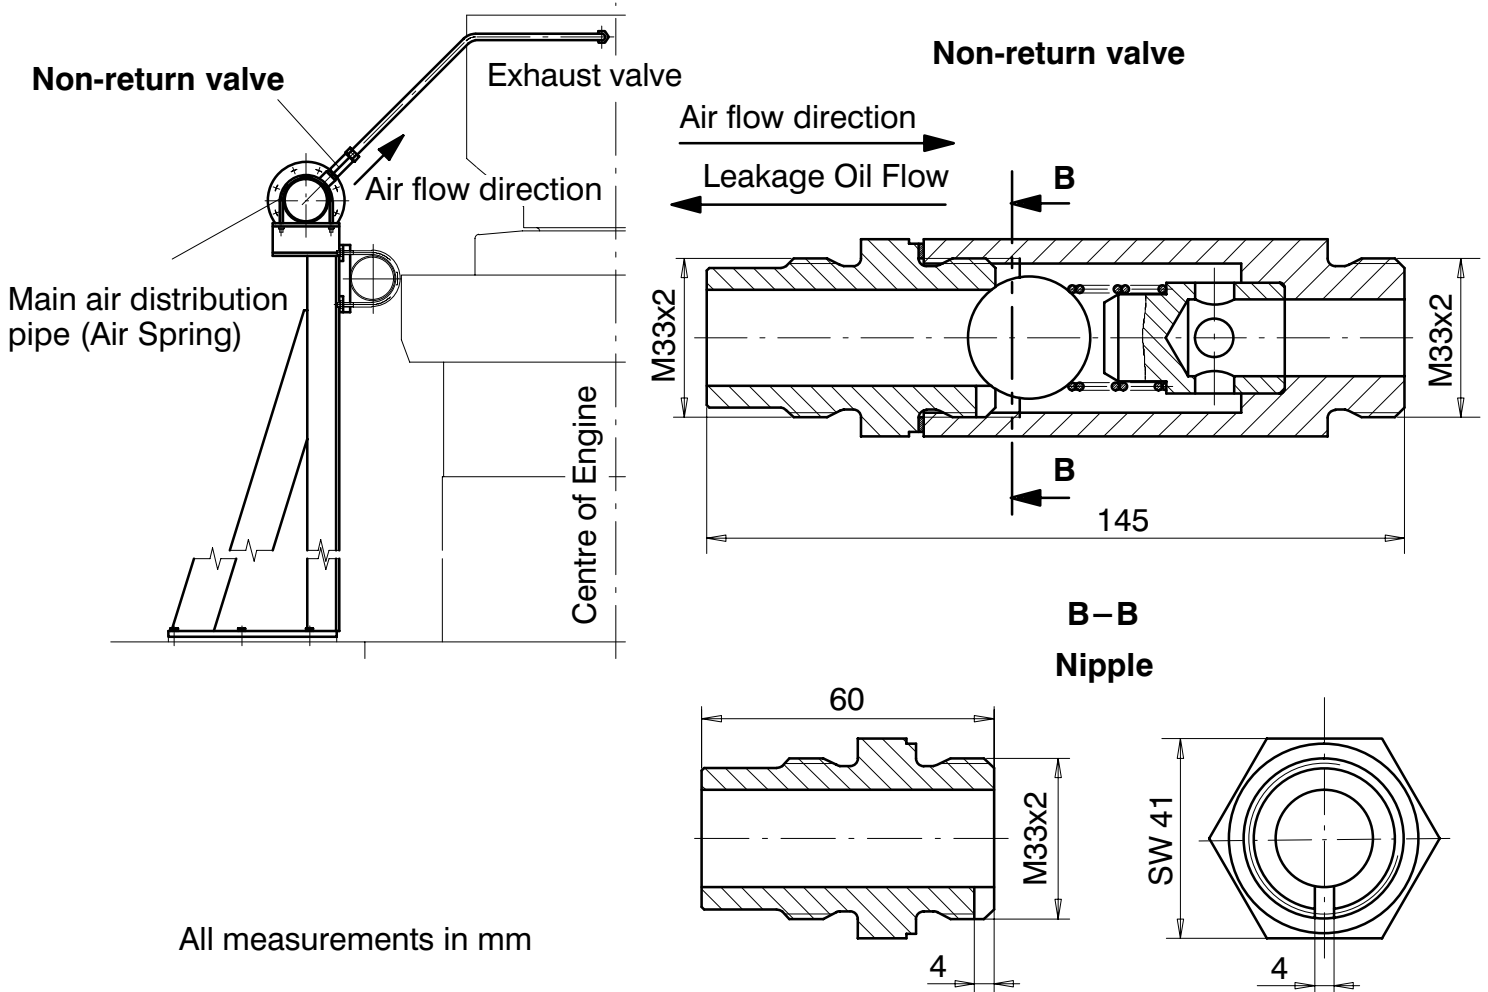
Fig. 4 Non-Return Valve in Air Inlet Pipe to Exhaust Valve (Air Spring)

These non-return valves (Fig. 4) have been introduced in 1995 to the RTA 84CU and later to the RTA 84C engines. The 4x4 mm groove in the nipple are important to drain the oil from the air spring chamber.

In the previous design the cross section of the oil flow between the ball and the four grooves was too small. The system oil could accumulate in the air spring chamber, resulting in damages of the valve drive.

In the latest design of the non return valve the numbers of grooves has been reduced to one only but the cross section of the oil flow has been increased.

Please verify on your engine accordingly.
