Typical wear mechanism of 2 stroke exhaust valves

Extend Component Life and Time Between Engine Overhauls.

MÄRKISCHES WERK

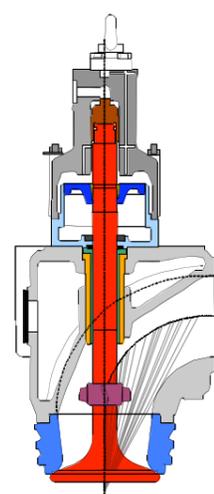
- Valve drive or hydraulic actuator
- Air cylinder
- Valve housing
- Valve guide
- Valve spindle
- Bottom piece or seat ring

Figure 01:
Main components of an exhaust valve

The design of the exhaust valves of all three engine builders are different in details, but the general function is the same, see figure-01. The main components of MC, RTA and UEC are:

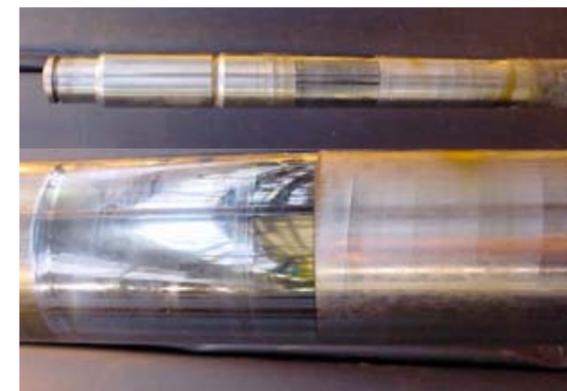
Figure 02:
Physical adhesion and abrasive wear of a hard-chromed valve spindle (MC-type after 15,000 hrs)

Adhesion and abrasive wear is very often found in the stem sealing area of hard chromed, MC valve spindles (see figure 02). Usually the limit of this stem diameter is reached after 12,000 - 18,000 hrs. MC valve spindles with HVOF-stem coating, as well as RTA- and UEC valve spindles with hard-chromed stems, reach a TBO (time between overhaul) of 24,000 - 36,000 hrs.

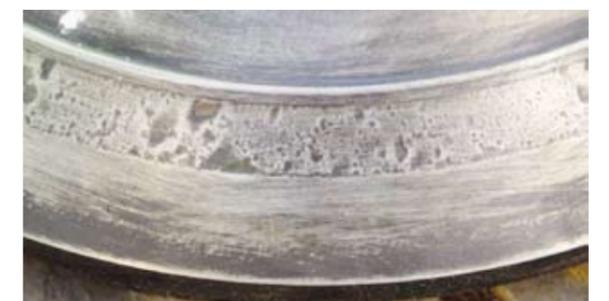
Figure 03:
Typical dent marks of the seat of a valve spindle (MC60-type Nimonic after 8,300 hrs)

Together with high seat pressure and a higher seat hardness of the bottom piece, the MC-type shows the highest probability and intensity of dent marks with TBOs of 6,000-18,000 hrs (see figure 03). The seats of RTA- and UEC-types require overhauls after 12,000 - 36,000 hrs.

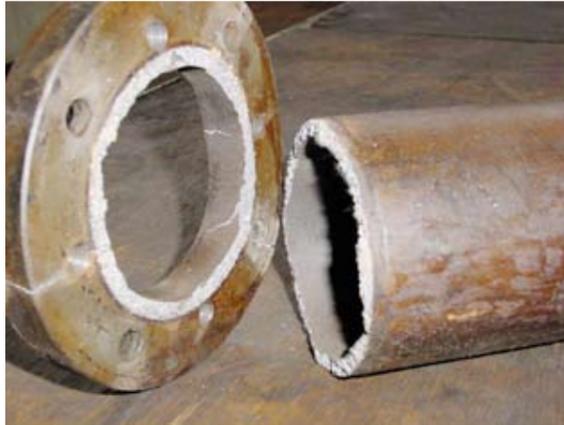
Figure 04a: Breakage of the valve guide during valve spindle disassembling

To disassemble exhaust valves, hydraulic power is usually necessary to remove the valve spindle from the valve guide. In some cases the sticking of the valve spindle is so extreme that the valve guide breaks during the operation (see figure 04a and 04b).

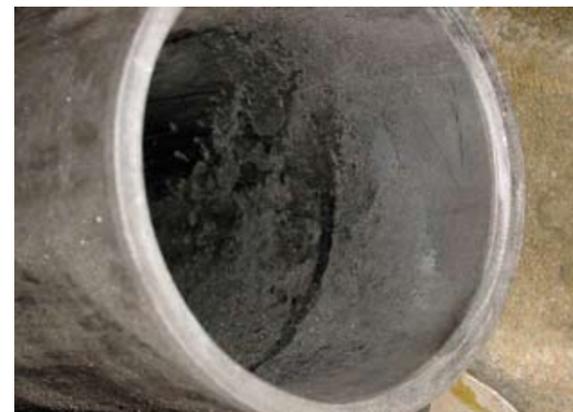
Figure 04b: Typical deposits of inner diameter of valve guide (MC70-type after 8,200 hrs)

Depending on the design of the valve guide, its inner diameter will display more or less deposit buildup. Exhaust gas enters into the clearance between valve spindle stem and the inner diameter of the valve guide, which allows deposits inside the guide (see figure 04). Due to this, MC-types need a replacement of the valve guide between 6,000 - 8,000 hrs to minimize the risk of the valve spindle sticking in the guide.

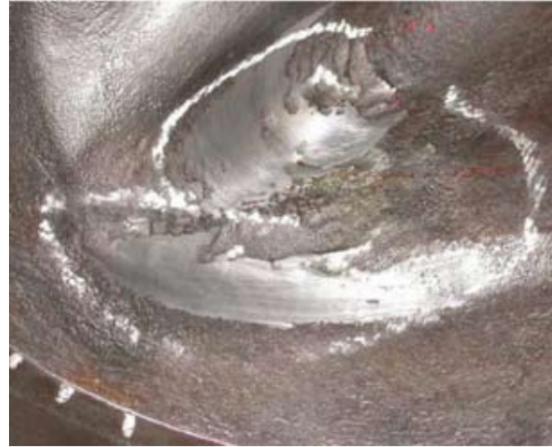
Figure 05: Low temperature corrosion of valve housing (MC-type 43,700 hrs)

Nearly all components of the exhaust gas channel show some low-temperature corrosion (see figure 05-07).

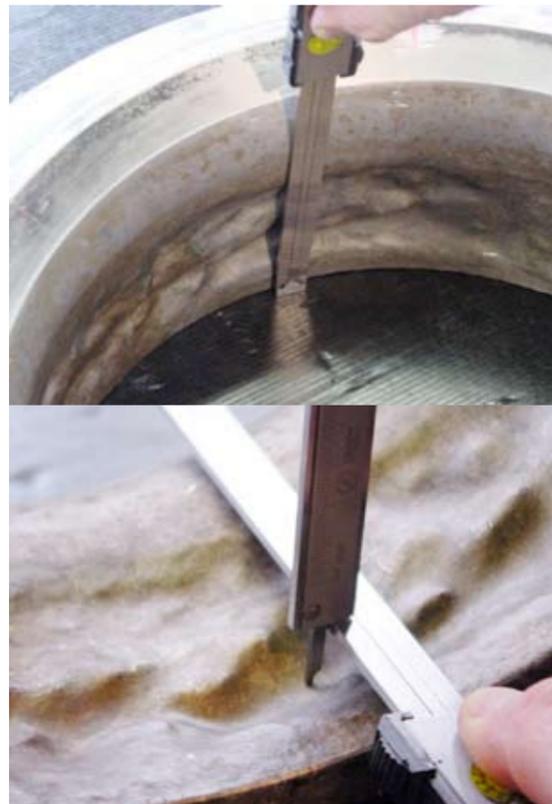
Figure 06: Low temperature corrosion of bottom piece (RTA-type after 28,420 hrs)

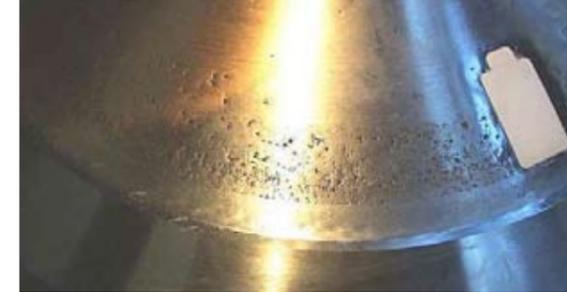
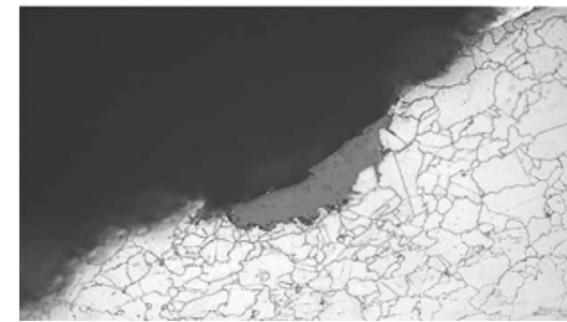
Figure 07: Low temperature corrosion (pitting corrosion attack) of under head radius of valve spindle (MC60-standard / 22,700 hrs)

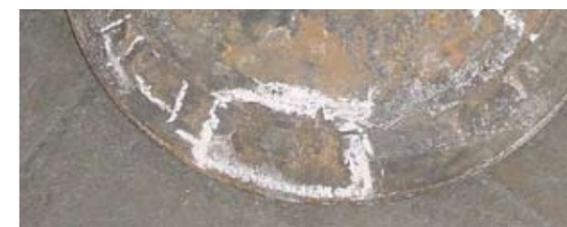
Figure 08: “Cobble stone corrosion” appearance of valve spindle failure through high-temperature corrosion (MC60 Standard-type)

The bottom of the valve spindle is mostly operating in the critical area of the high-temperature corrosion seen as “cobble stone corrosion”. The wear rate is between 0,2 - 1,0 mm / 1,000 hrs. depending on valve material and type of engine. The limit for remanufacturing is only reached after 12 mm. This leads to a TBO of about 12,000 - 60,000 hrs. Figure 09 shows micro cuts of Nimonic with high-temperature corrosion.

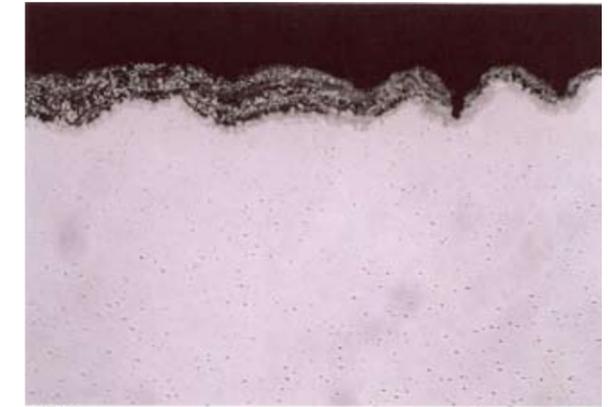
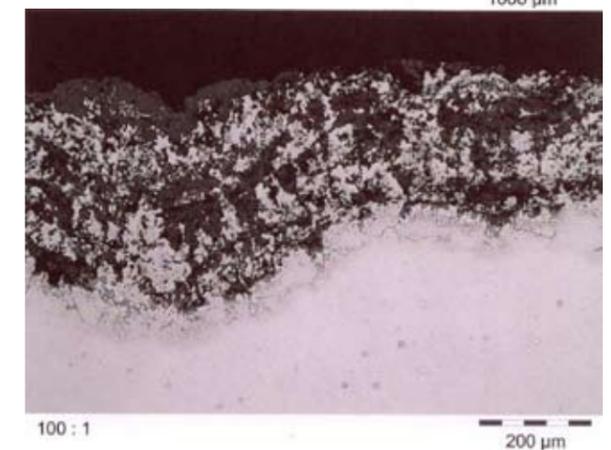
Figure 09: Micro cuts of Nimonic with high-temperature corrosion.

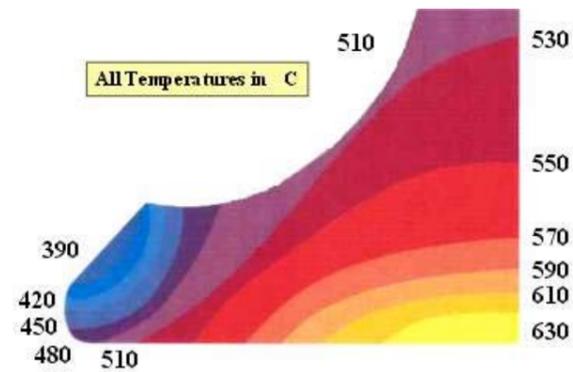
Figure 10: Typical temperature distribution of a Nimonic exhaust valve head

The valve spindle is the component with the maximum thermal stress. Most of fatigue problems are documented at the valve spindles. Figure 10 demonstrates a typical heat distribution across a Nimonic valve head.

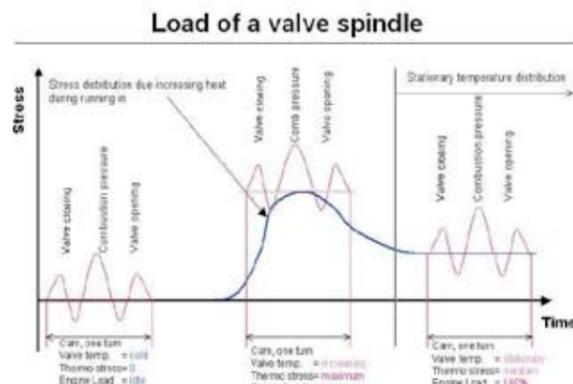
Figure 11: Mechanical and thermal load as function of running in and stationary operation

The maximum thermal stress takes place during the warm-up period. During this period the temperature at the center of the valve bottom and the seat reaches the maximum difference. Under regular operating conditions the temperature distribution is much lower. The mechanical load of a valve spindle is nearly constant between warm-up and regular operating, see figure 11.

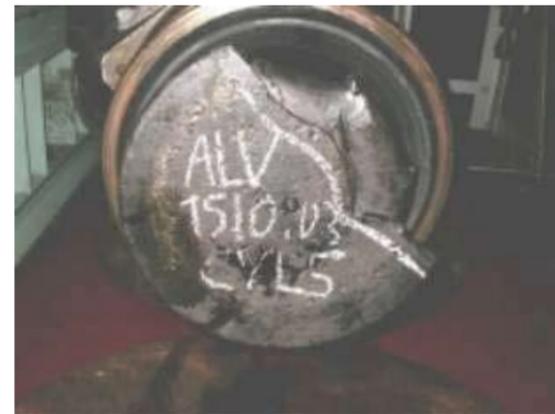
Figure 12: Catastrophic failure of a repaired valve spindle (RTA72 Nimonic-type 740 hrs after repair)

There are two typical failure reasons. One is a crack that starts in the under head radius. After the micro cracks get to a critical length, the speed of the crack growth increases. A catastrophic failure follows, with parts of the spindle dropping down into the combustion chamber (see figure 12 and 13).

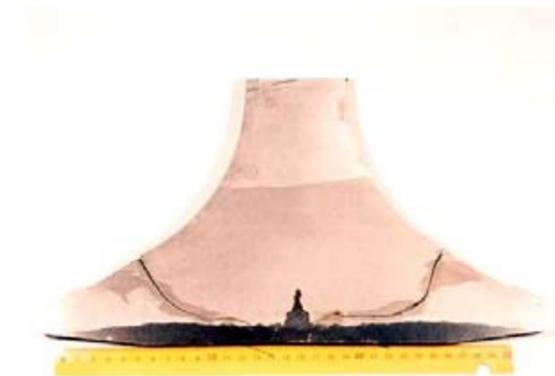
Figure 13: Macro cut through the center of a valve head (RTA62 Nimonic-type 6,430 hrs after repair)

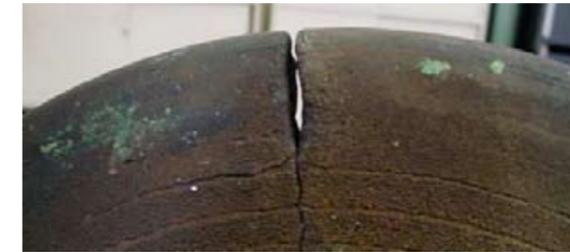
Figure 14: Failure of a valve spindle (RTA84 Nimonic type 5,270 hrs after repair).

The second failure reason is: Micro cracks starting in the outer diameter of the valve bottom. After reaching the seat area blow-byes are created and the valve spindle is destroyed (see figure 14).

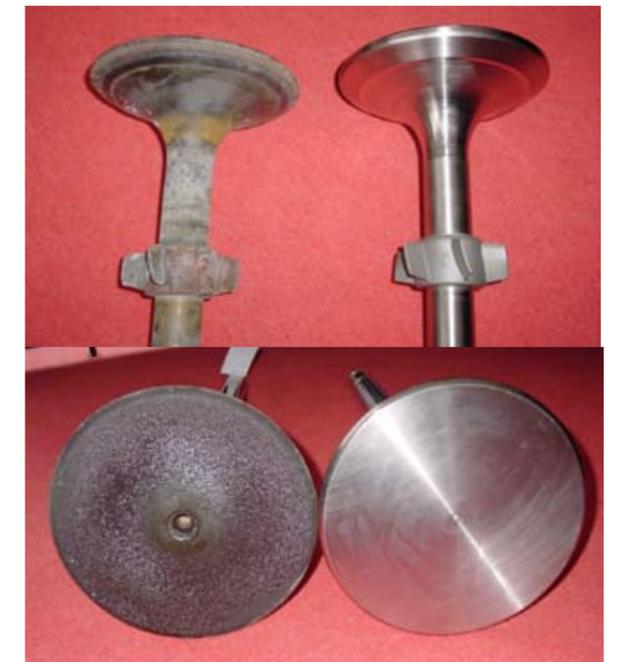
Figure 15 a/b: Nimalike spindle before and after remanufacturing

Nimalike is used in two ways: To extend the lifetime of a standard valve spindle to a lifetime similar to Nimonic, or to remanufacture Nimonic valve spindles in a way that leads to “close to new” conditions after the process (see figures 15 a/b).

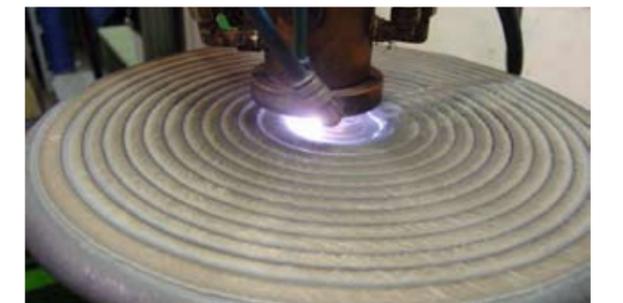
Figure 16: PTA-welding

The competence to perform this remanufacturing method is a combination of long-time experience in the field and manufacturing technology. The experience is coupled with continuous improvement of manufacturing processes and intensive R&D in the fields of metallurgy and welding processes (see figure 16).

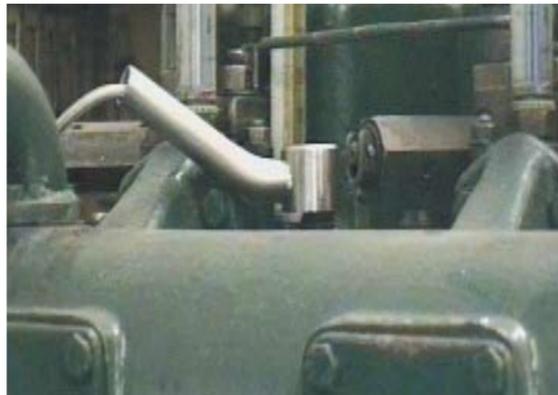
Figure 17: Leakage Measure System onboard in use

For this reason MWH provides the "Leakage Measure System", a mobile diagnostic system which is able to detect leakages at the cylinderhead to prevent fatal failures of a running engine. The principle is based on measurement of ultrasonic sound by using one simple and robust sensor (WEHNER, ALBERT 2001).

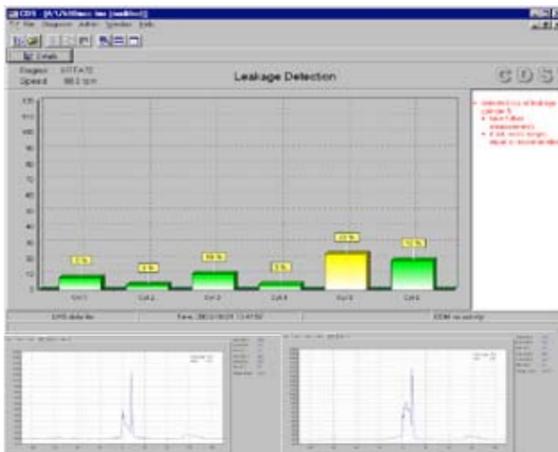
Figure 18: Documentation of the result of leakage detection and valvetiming/ignition

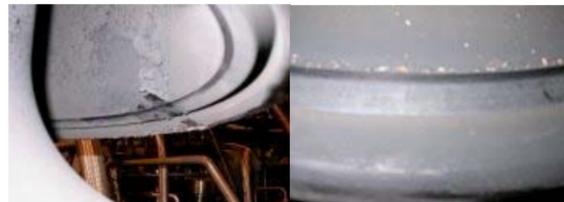
Figure 19: Seat ring and valve spindle show no dent marks after app. 1,000 hours.

First field tests are ongoing with a MC70 engine. Inspections have proven that the Turnomat® works as designed (see figure 19).
