## **Service Bulletin**

**RTA-26**

**Technical Information to all the Owners  
of Sulzer RTA 58, 68, 76 and 84 Type Engines  
with WATERCOOLED PISTONS**

## **Loss of Material on Piston Crowns due to High Temperature Corrosion and Erosion**

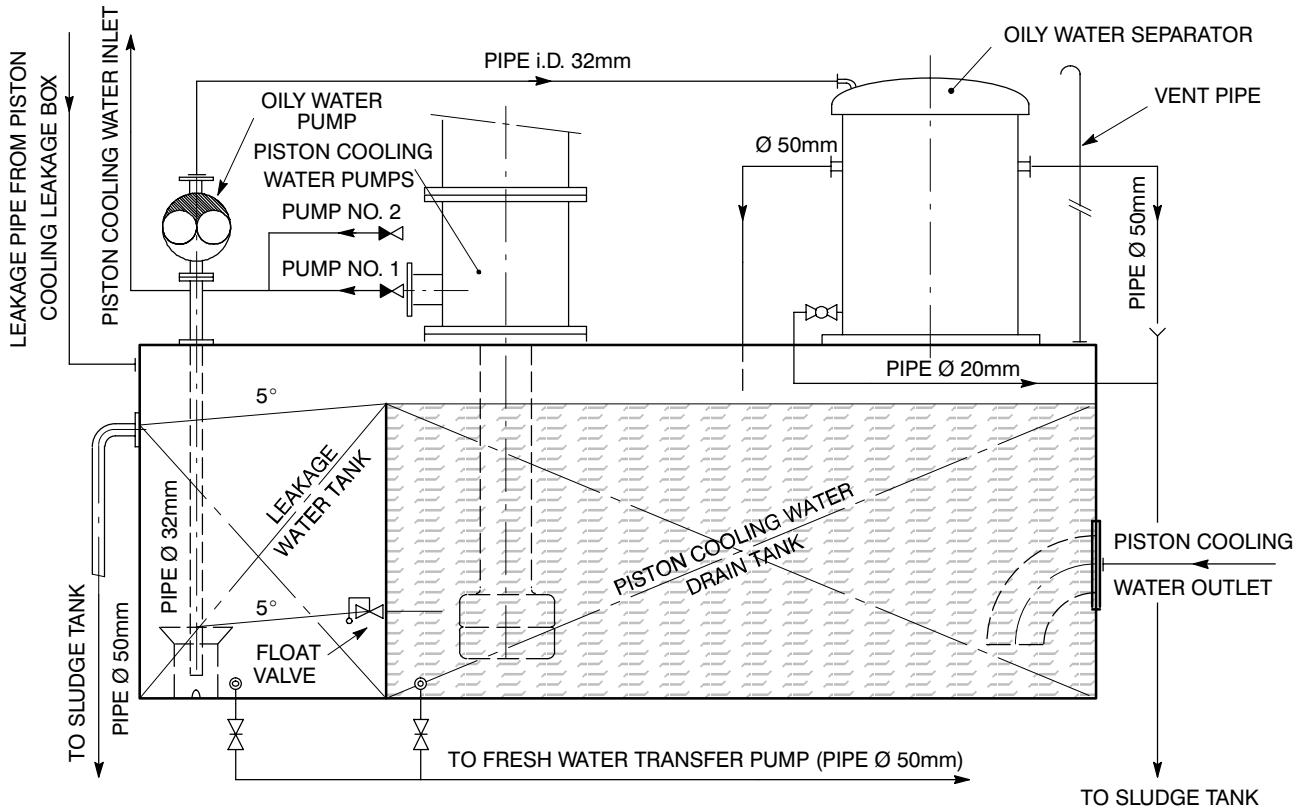
## Existing Piston Cooling Water System (as Example)

The layout of the piston cooling water system is often not according to the best specification and can therefore cause problems, which can in turn lead to contamination of the piston cooling water.

The oily water separator may be a static or centrifugal type. In case the actual arrangement of the leakage water tank section is different, the indicated proposal may serve as a guideline for the improvements.
