Service Bulletin

RTA-46

Technical Information to all Owners / Operators
of Sulzer RTA “-8 and -2 Series” Engines

CRACKS IN COLUMN

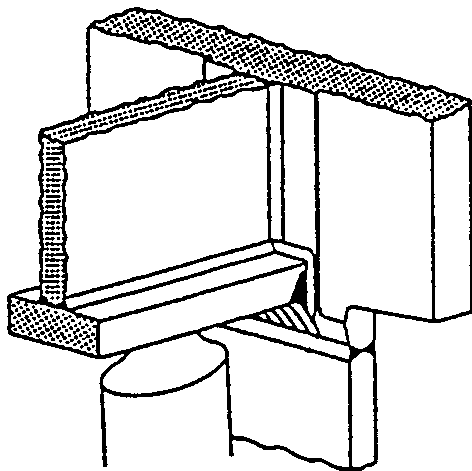
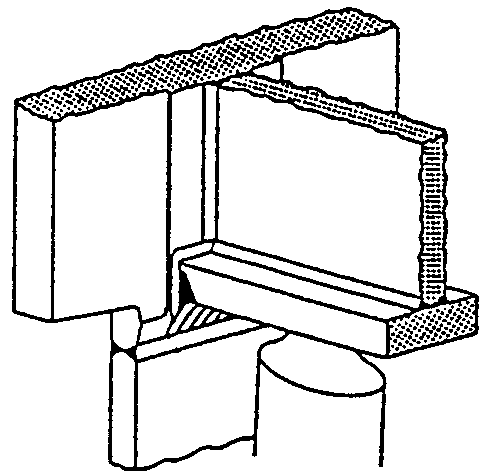
Crack in the Corner of the Cross Beam Monoblock Column

5.3.1. In the Case of Cracks in the Corner of the Cross Beam

- A repair can be scheduled for the next drydocking or long loading / discharging period. However, the engine must be immobilized for the repair purpose.
- The VIT must be deactivated
- Normally no restrictions for load or speed

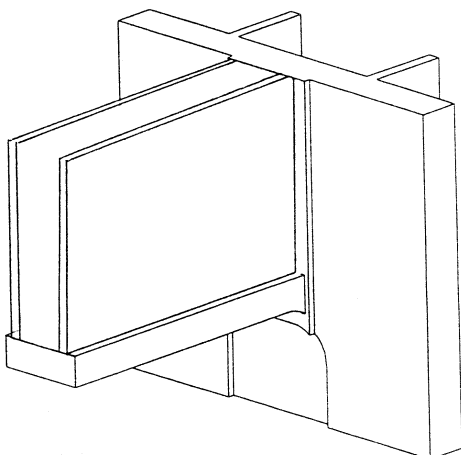
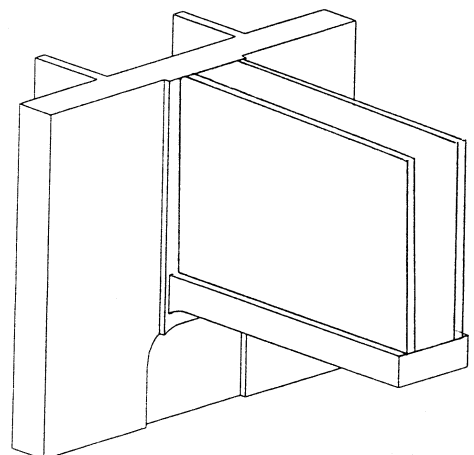
Crack in the Corner of the Cross Beam Single A Frame Column

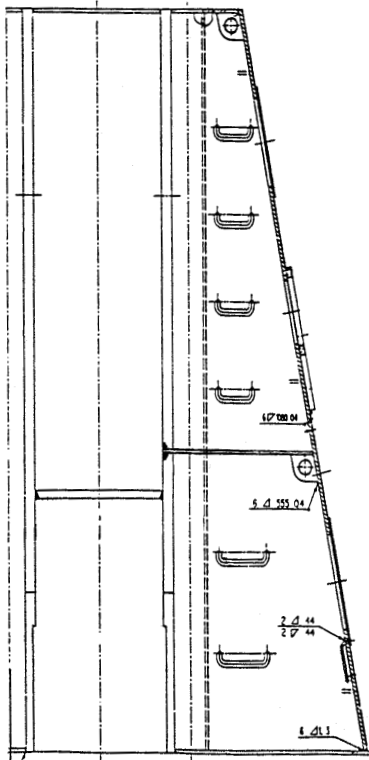
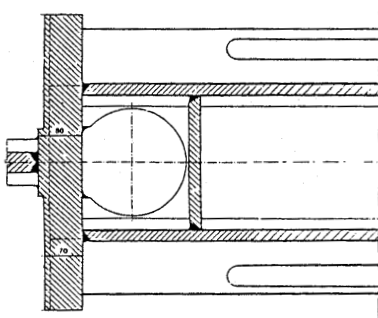
Crack in the Stiffening Rib

5.3.2. In the Case of Cracks in the Stiffening Rib and Guide Plate

- Crack in the vertical welding seam must be repaired as soon as possible otherwise a crack propagation towards the transverse plate will occur
- The VIT must be deactivated
- Normally no restrictions for load or speed
- Condition of the guide shoes whitemetal layer must be inspected more frequently

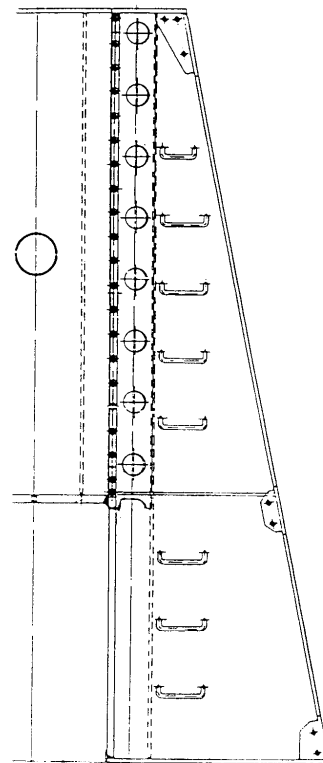
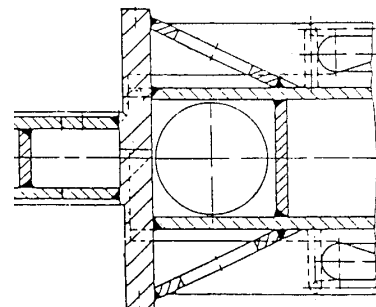
Crack between Guide Plate and Transverse Plate

5.3.3. In the Case of Cracks in the Guide Plate and Transverse Plate

- Crack in the welding seam must be repaired as soon as possible
Negative running clearances between the guide shoe and unloaded guide rail due to expanded open crack
- The VIT must be deactivated
- Normally no restrictions for load or speed
- Condition of the guide shoes whitemental layer must be inspected more frequently
